KU LEUVEN

Glitched on Earth by Humans: A Black-Box Security Evaluation of the SpaceX Starlink User Terminal

Lennert Wouters

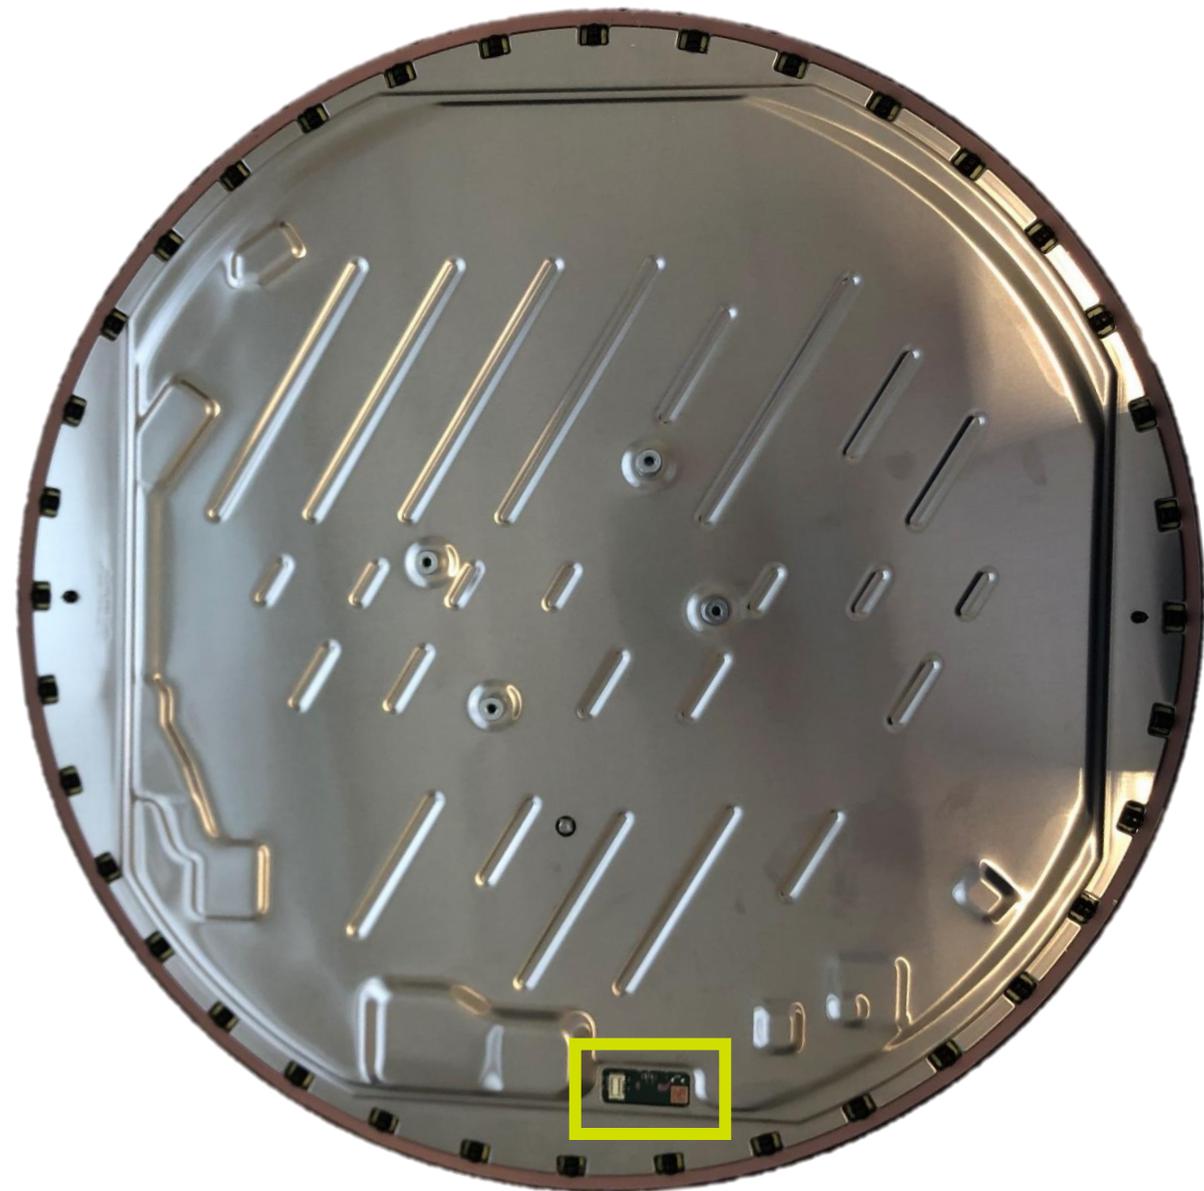
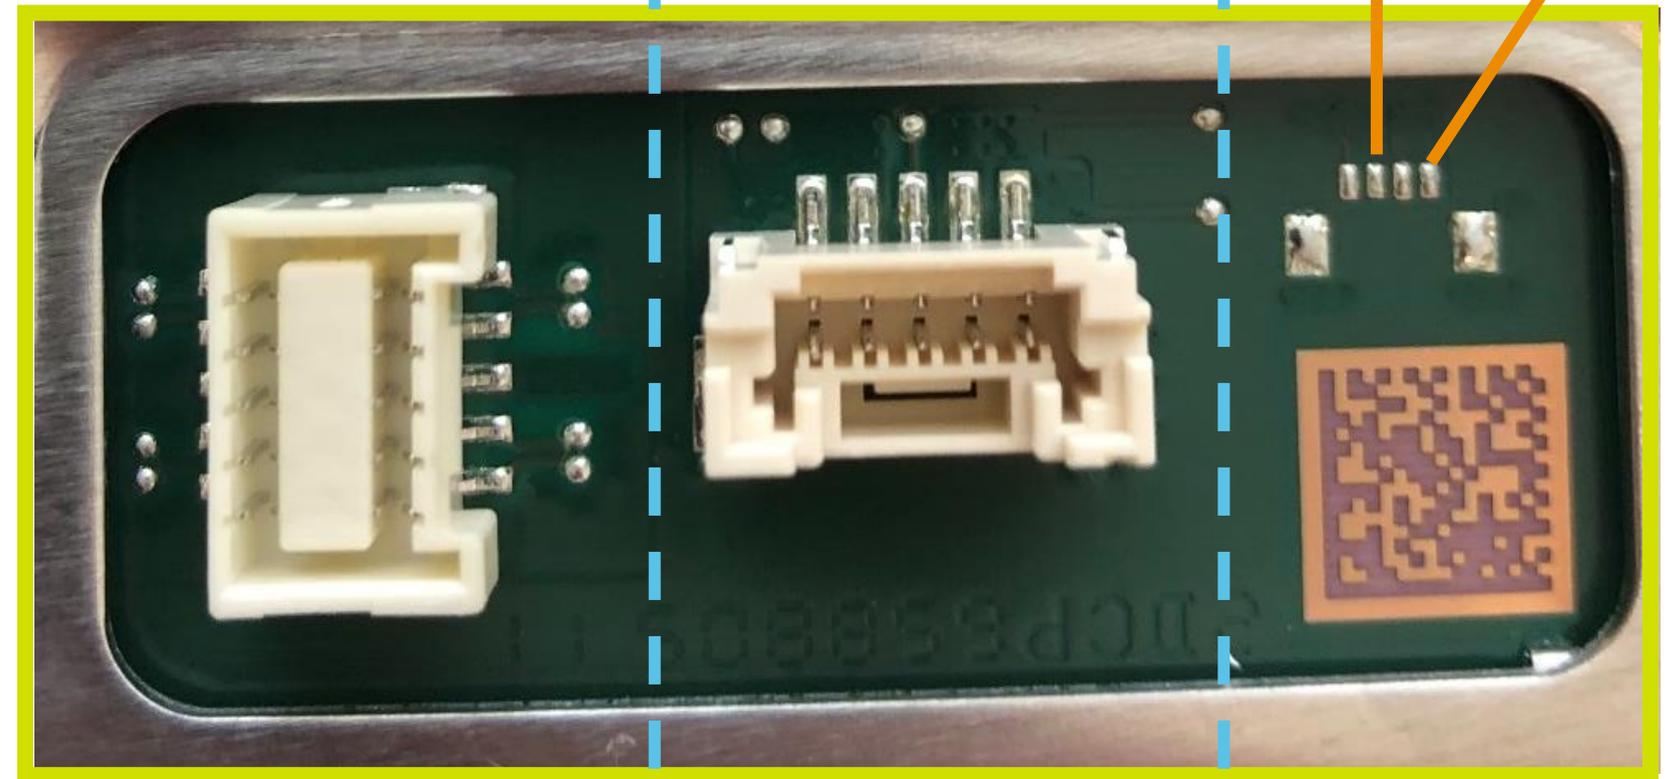
Accessible connectors on V2*

ethernet + power

JST BM10B-ZPDSS-TF(LF)(SN)

motors

JST BM05B-ZESS-TBT(LF)(SN)

UART

UT TX
UT RX

*V1 hardware had an extra connector, V3 does not have easily accessible connectors

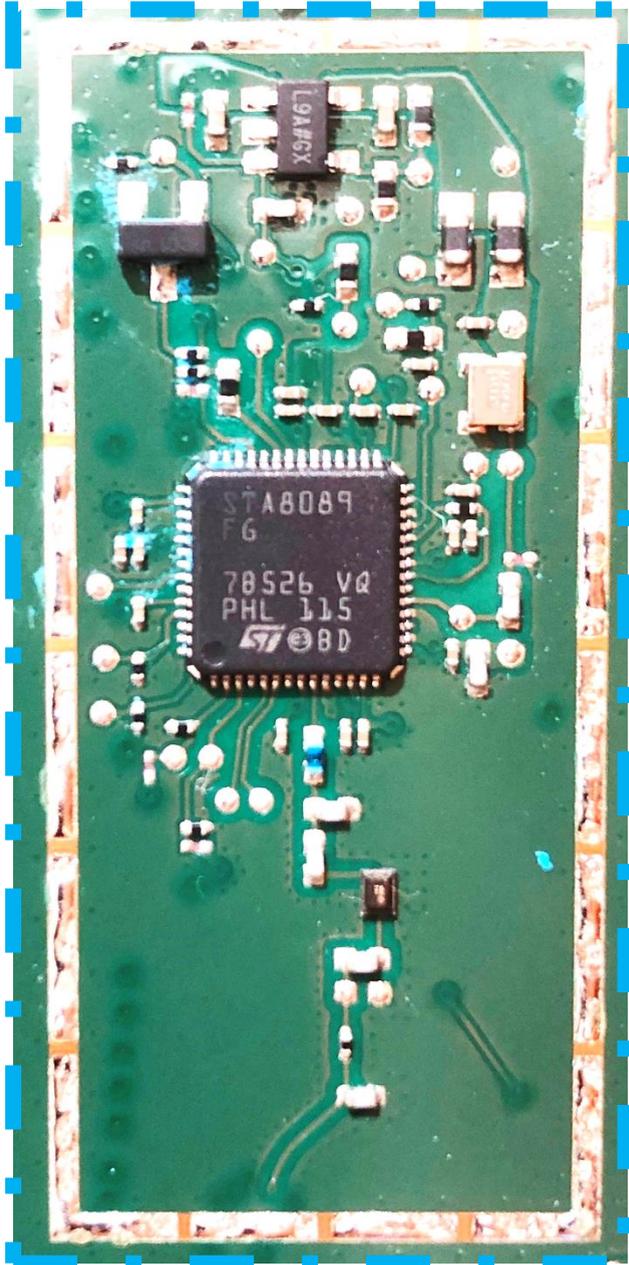
GPS receiver

STM STA8089

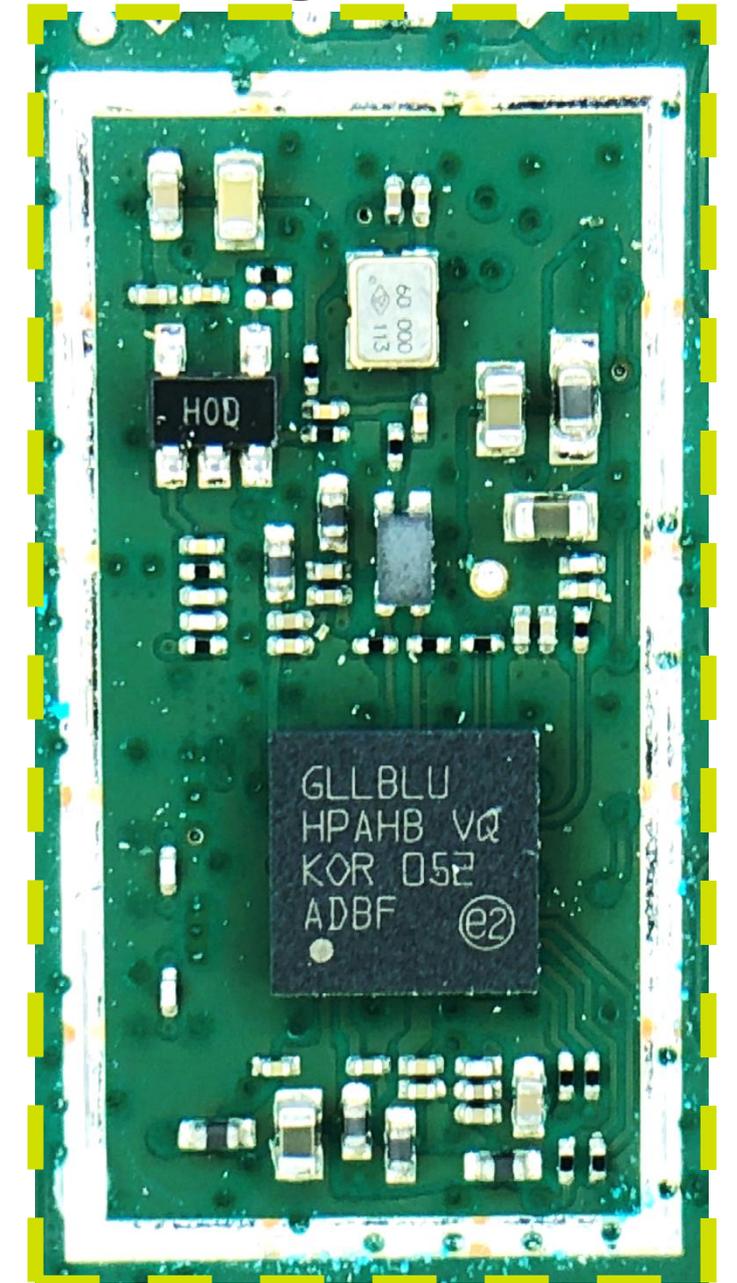
Clock generation

GLLBLU

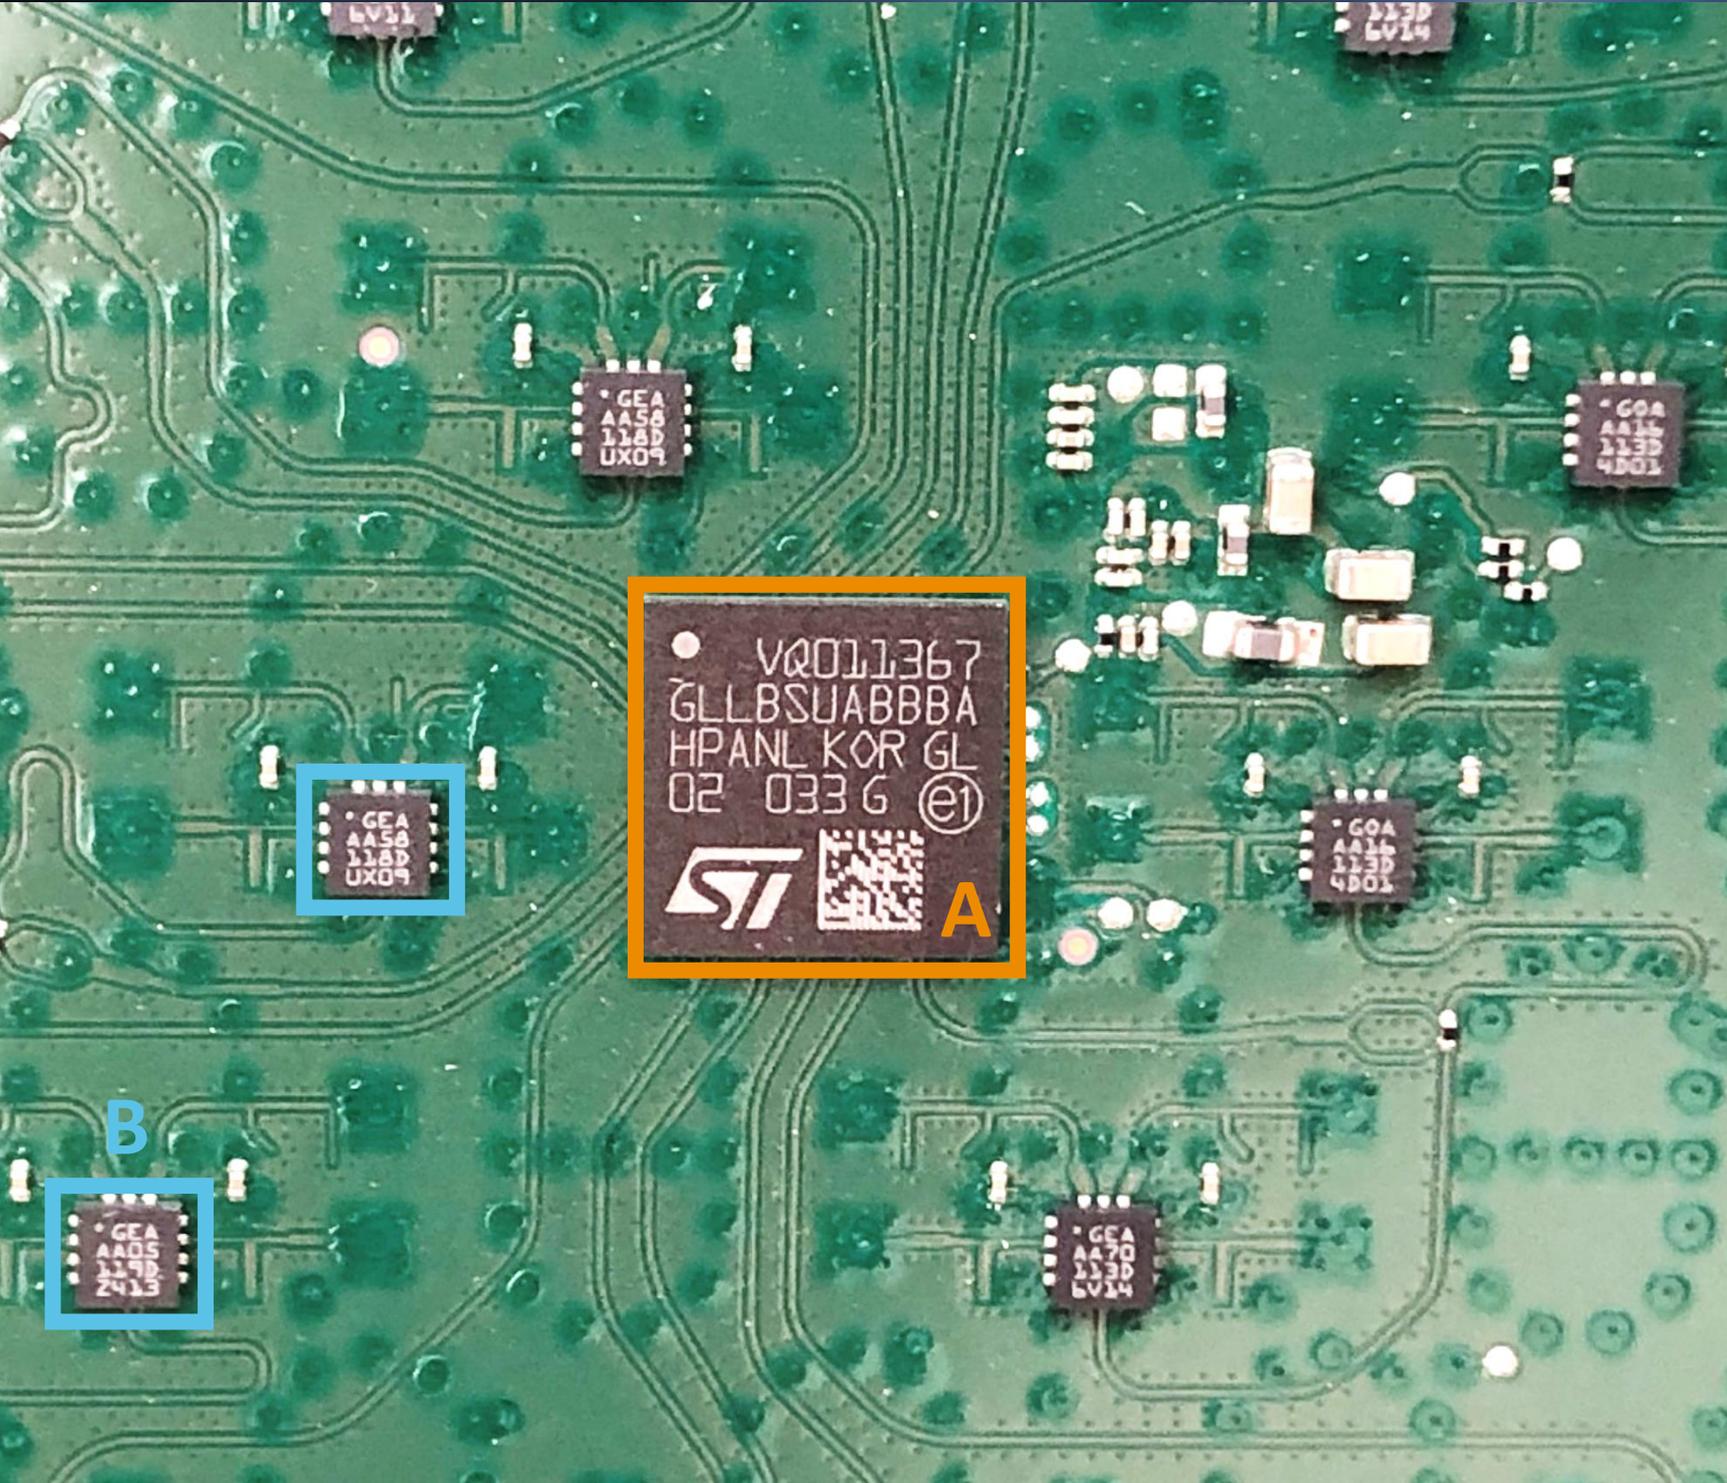
RF Components

- (A) Digital BeamFormer (DBF)
 - STM GLLBSUABBBBA
 - Codename: **SHIRAZ**
- (B) Front-End Module (FEM)
 - Codename: **PULSAR(AD)**
- V2 hardware and up:
 - 1 DBF → 16 FEMs

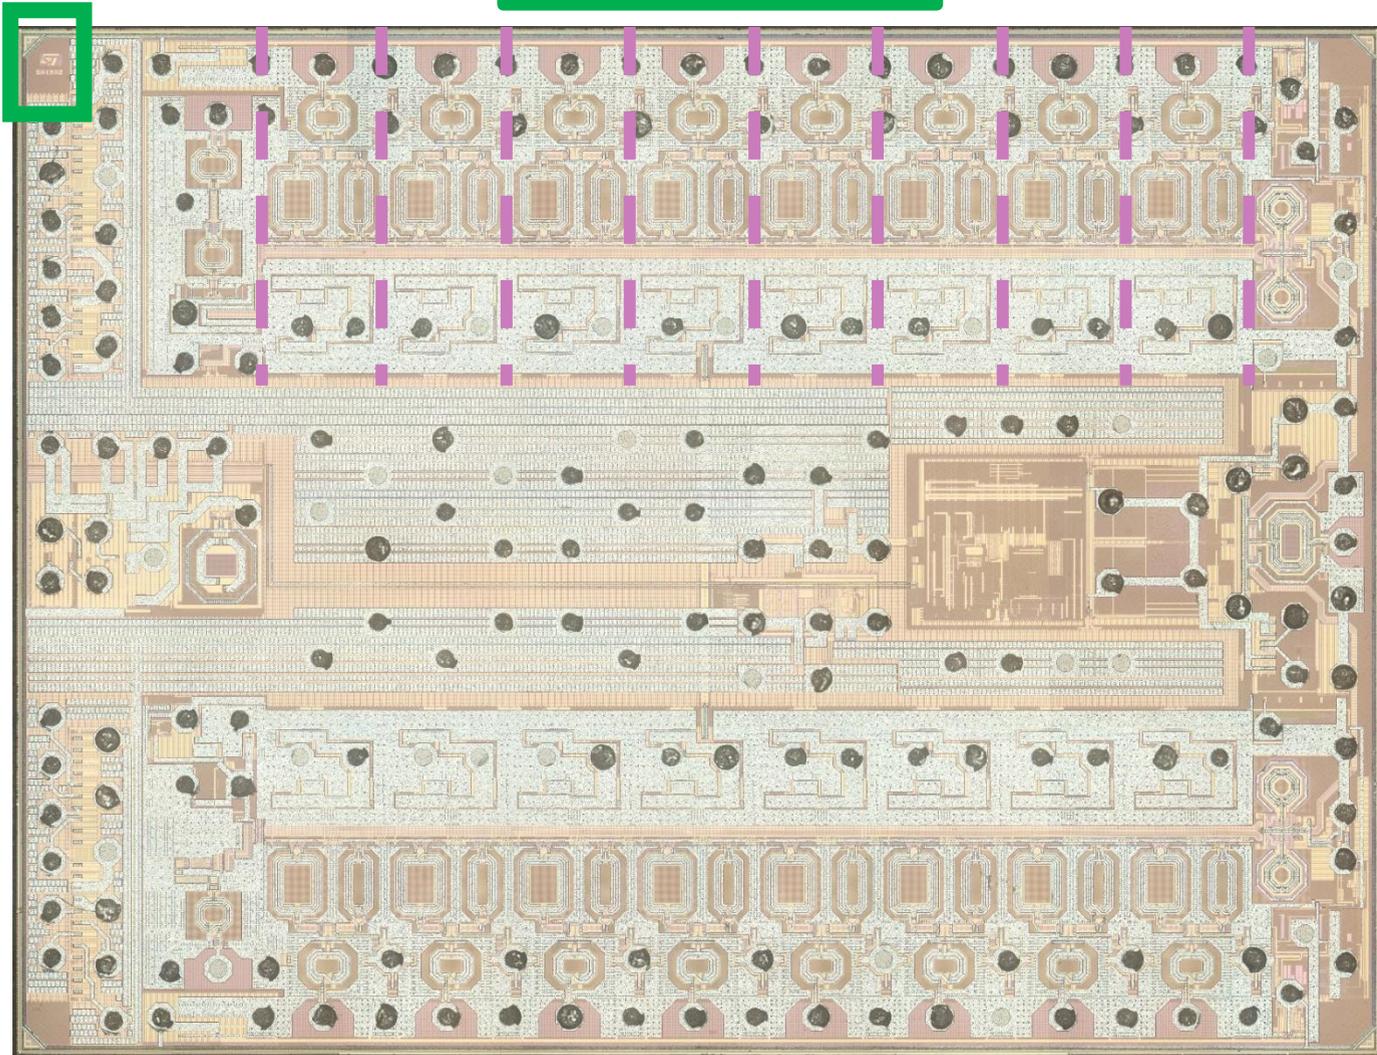
SHIRAZ

siliconpr0n.org/archive/doku.php?id=mcmaster:spacex:gllbsuabbba-shiraz

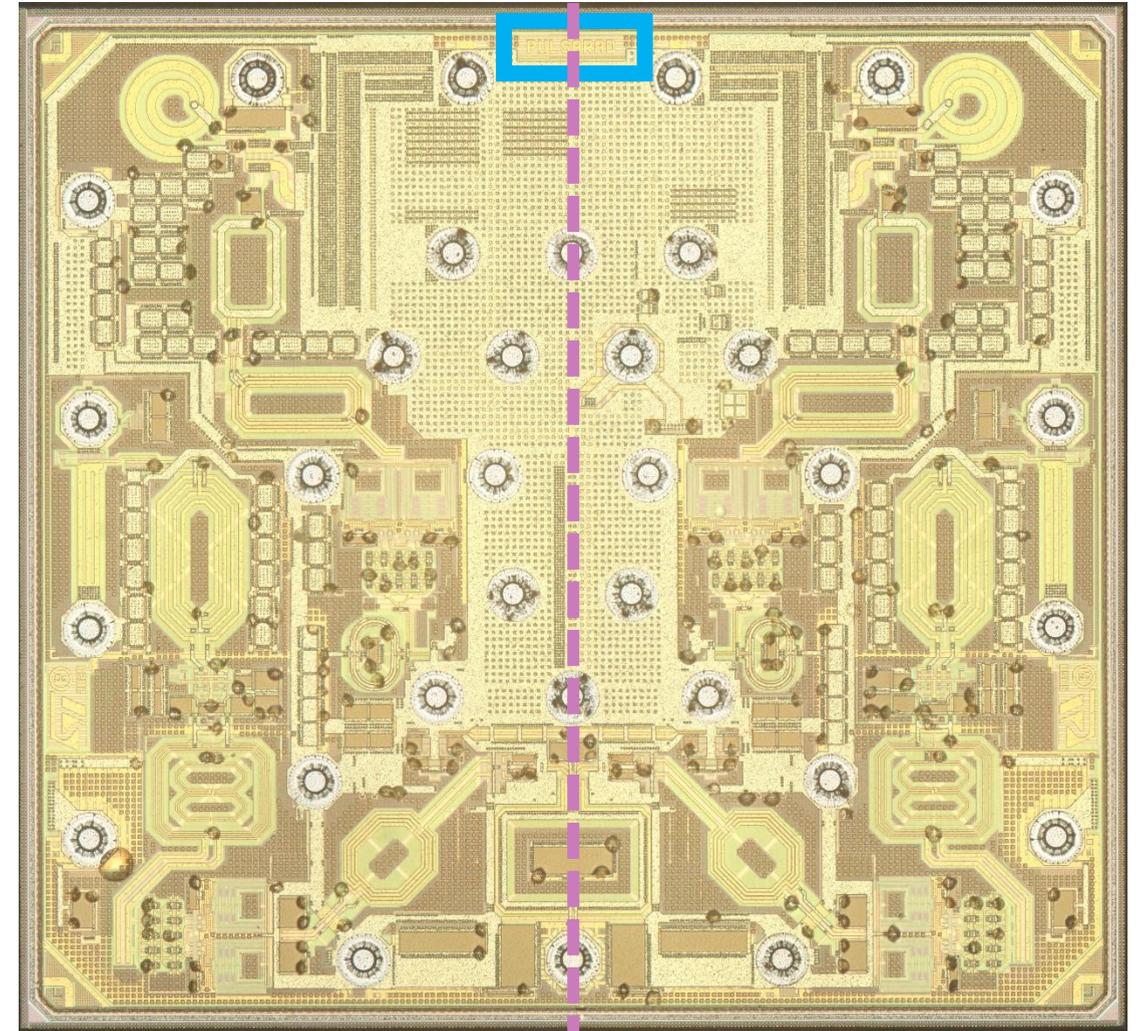
PULSARAD

[id=mcmaster:spacex:gea-aa12-109d-tg02-pulsarad](https://siliconpr0n.org/archive/doku.php?id=mcmaster:spacex:gea-aa12-109d-tg02-pulsarad)

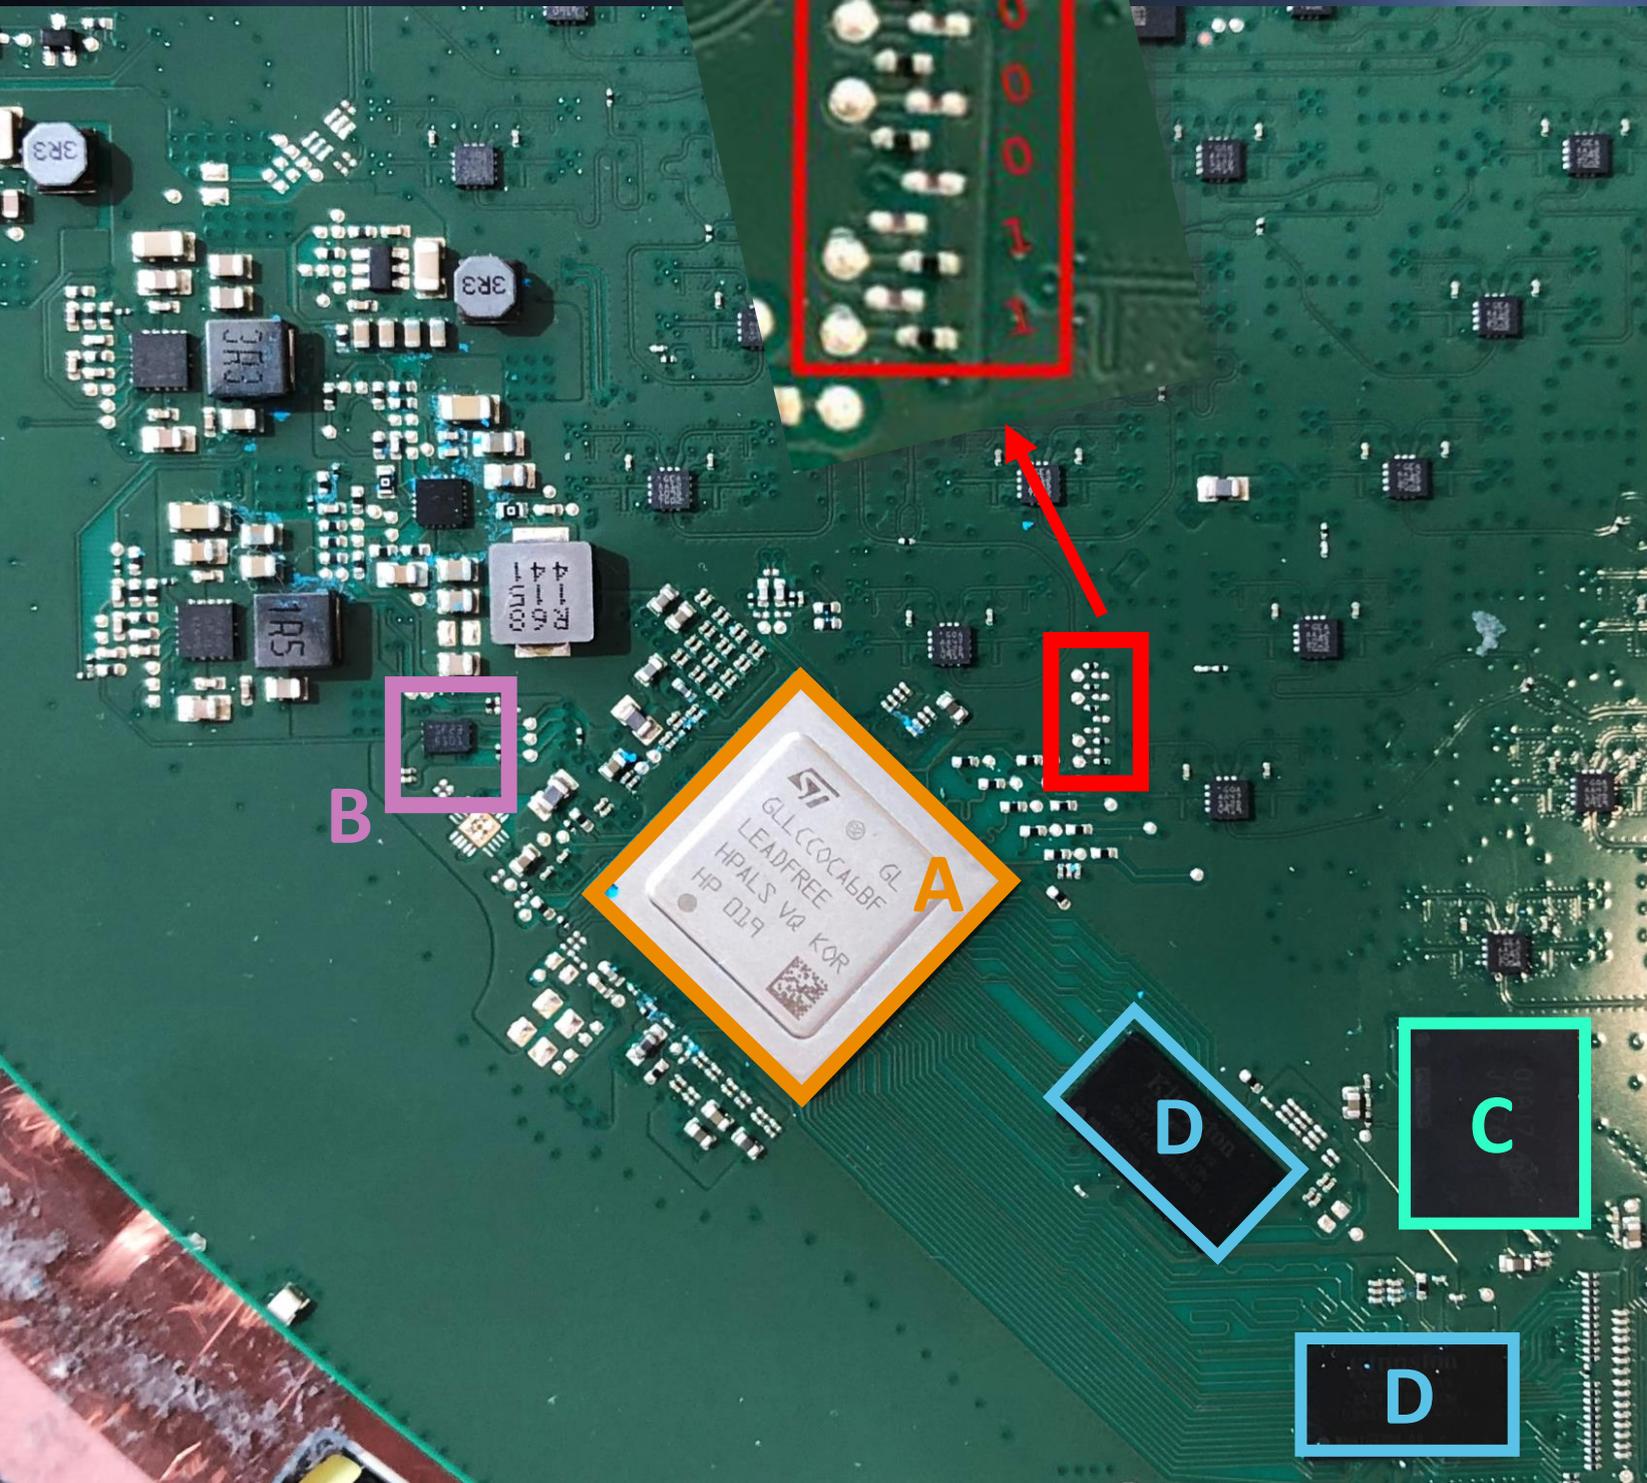
- (A) System-on-Chip
 - Custom quad-core ARM Cortex-A53
 - ST Microelectronics
 - GLLCCOCA6BF (cut 3?)
 - GLLCCODA6BF (cut 4?)
 - Codename: **CATSON**
- (B) Secure Element
 - STM STSAFE-A110
- (C) 4GB eMMC
- (D) 2 x 4Gbit DDR3

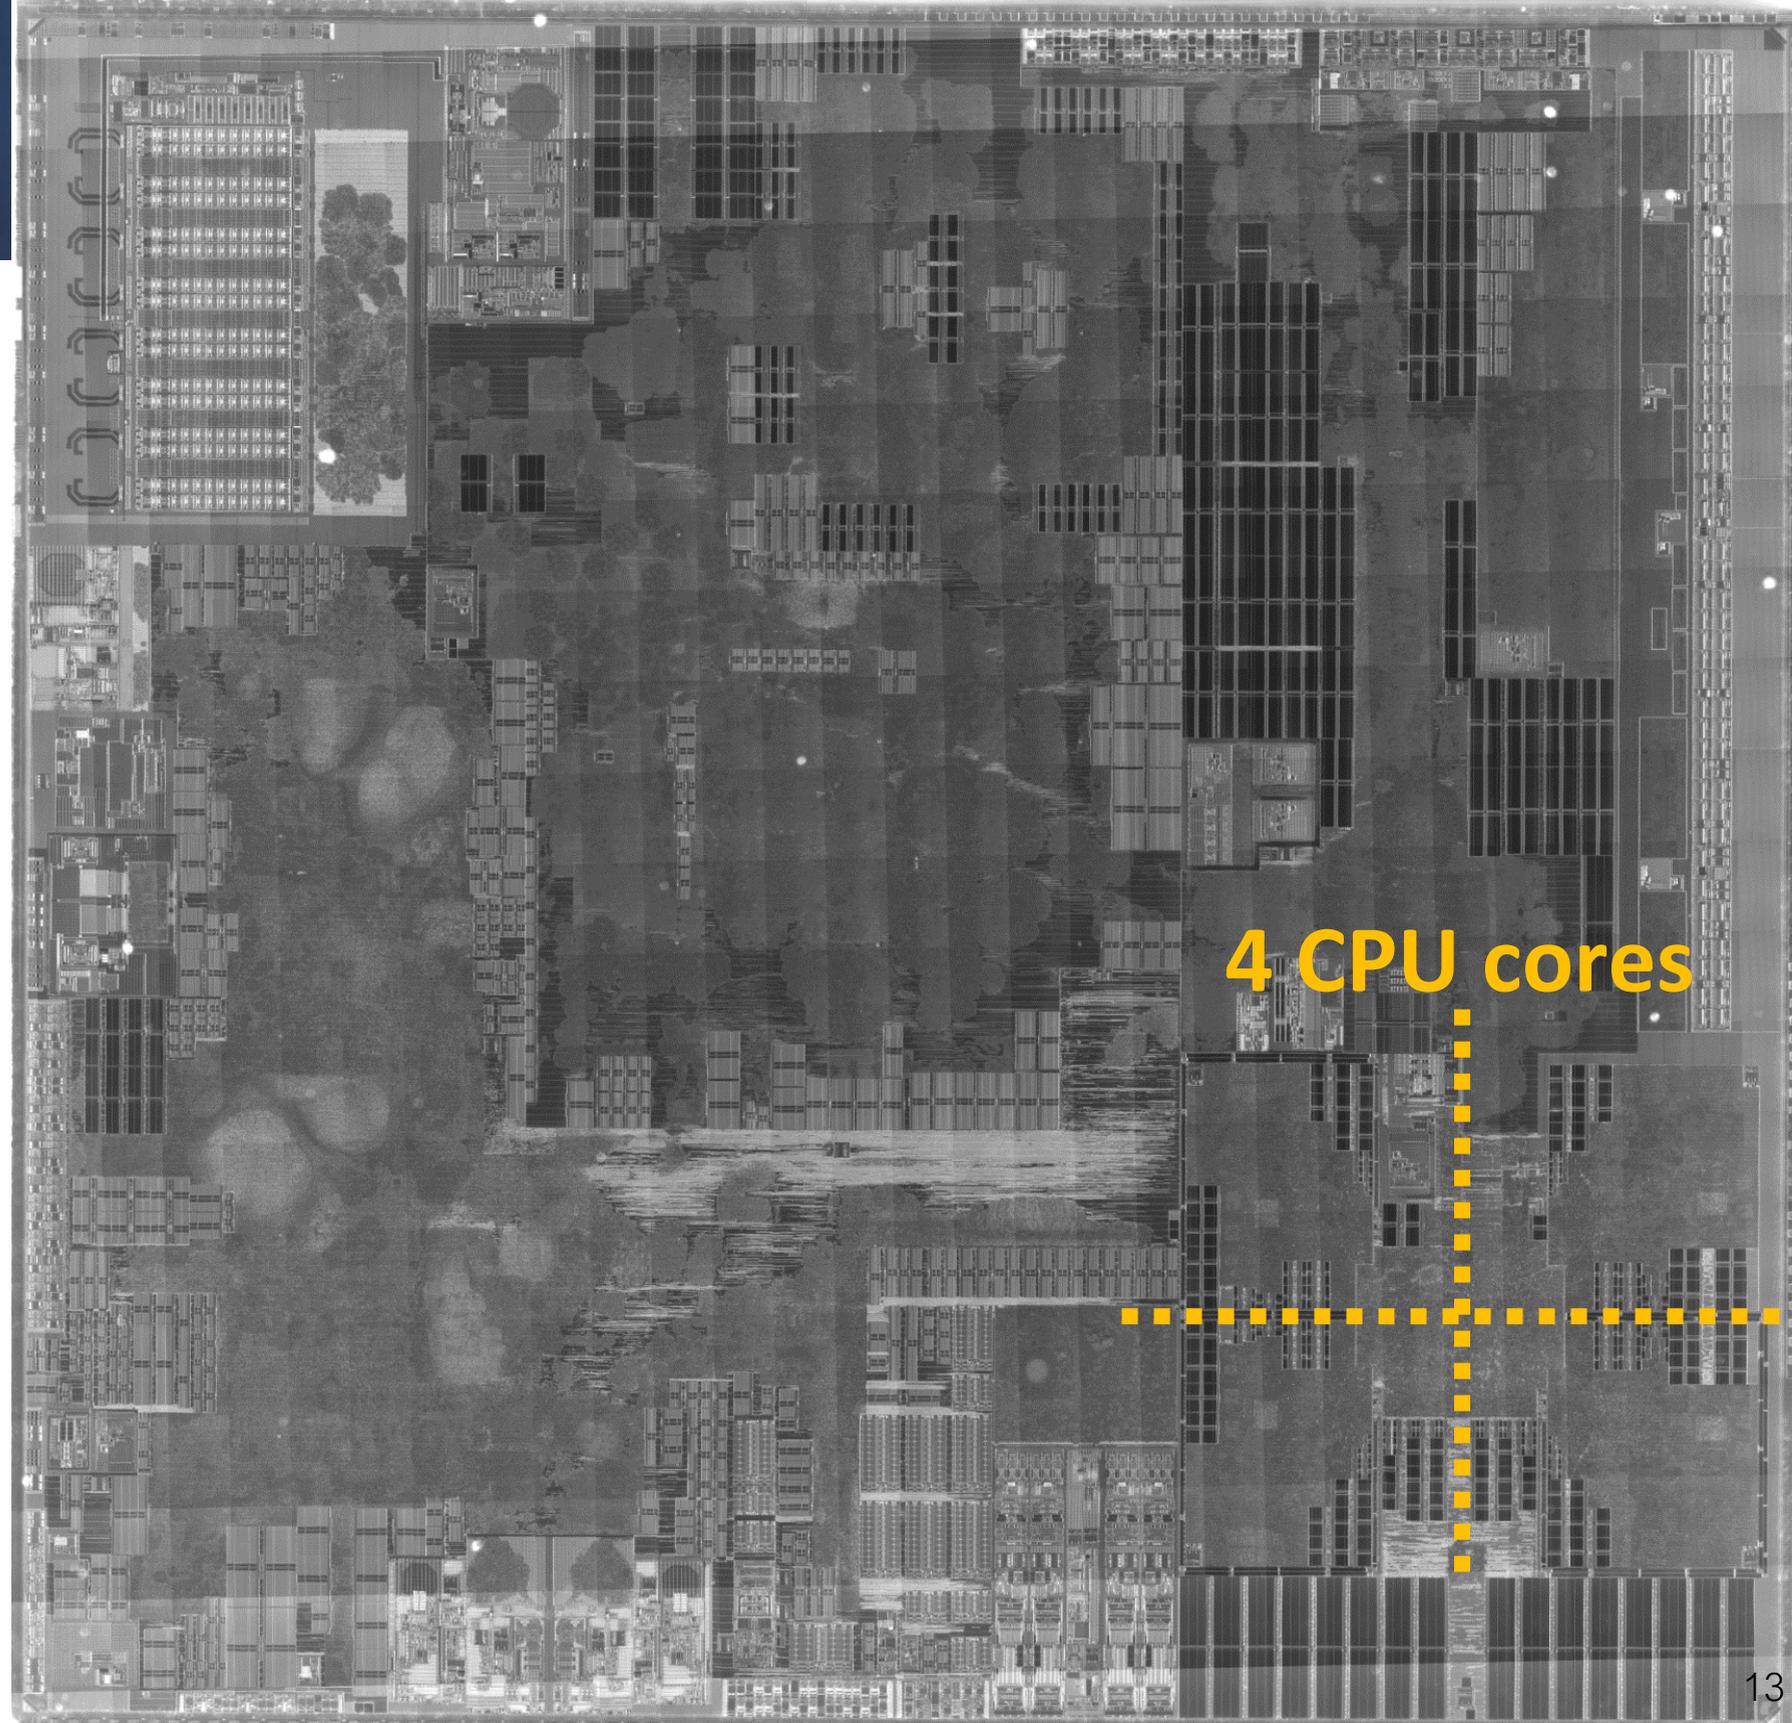
- through substrate image
 - GLLCCOCA6BF (cut 3?)
 - Thorlabs NIR camera
 - Mitutoyo NIR objective 50x
- Can help narrow down interesting locations for some physical attacks
- Full resolution version will be available on siliconpr0n.org!

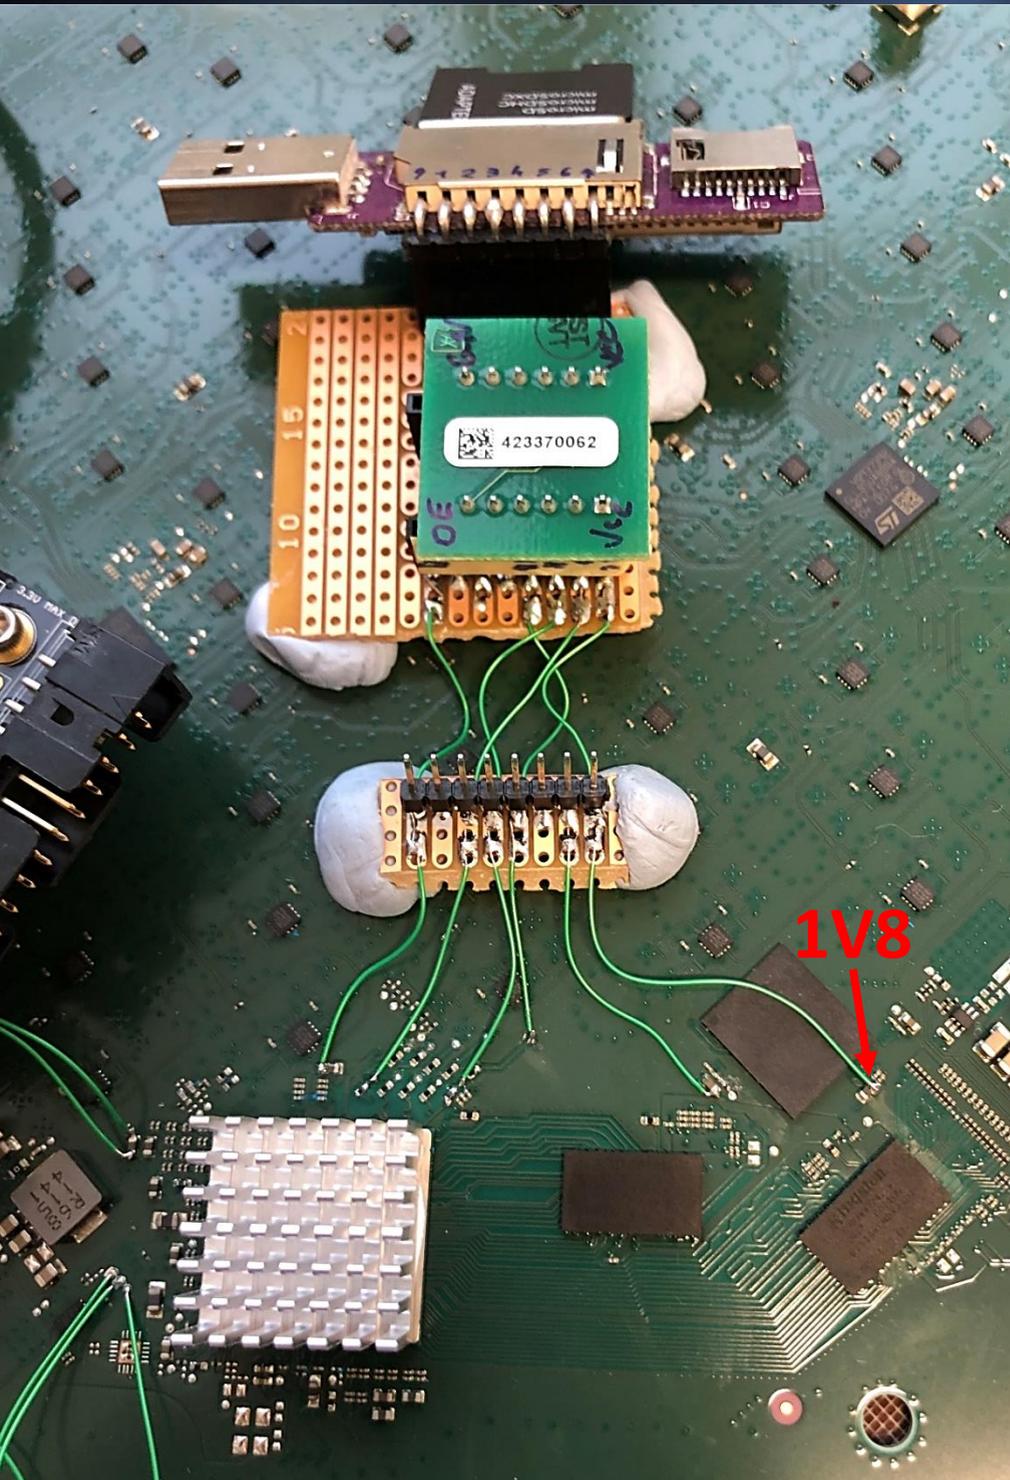
Reading eMMC in-circuit

SD card reader

TXS0202EVM
Level shifter

← What I did

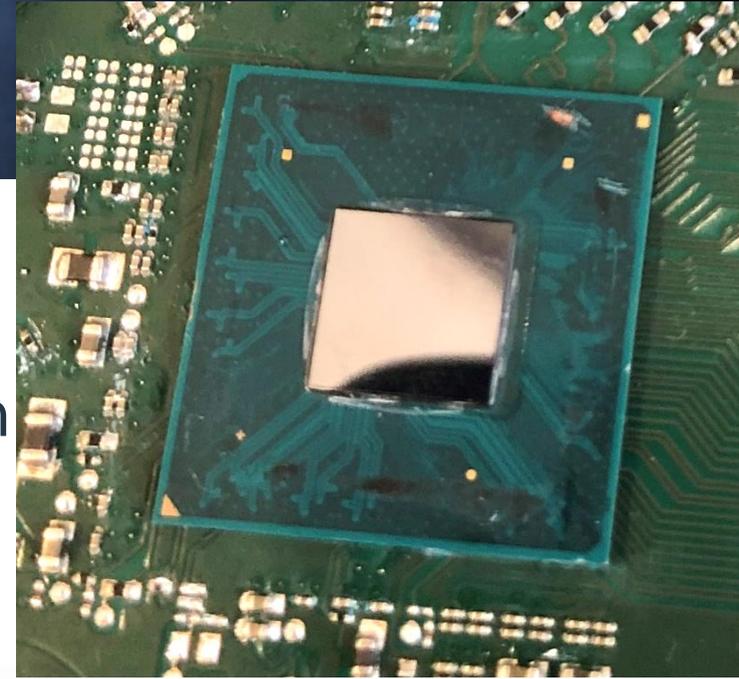
Fault injection

- ✓ Flip-chip packaging exposes die backside
 - Laser Fault Injection, Body Bias Injection, Electromagnetic Fault Injection
- x PCB is too big for our automatic XYZ positioning equipment
 - Likely cumbersome to do on a roof...

x No development kits

- Differential clock input
 - (But PLL?)
- Reset line
- Voltage Fault Injection

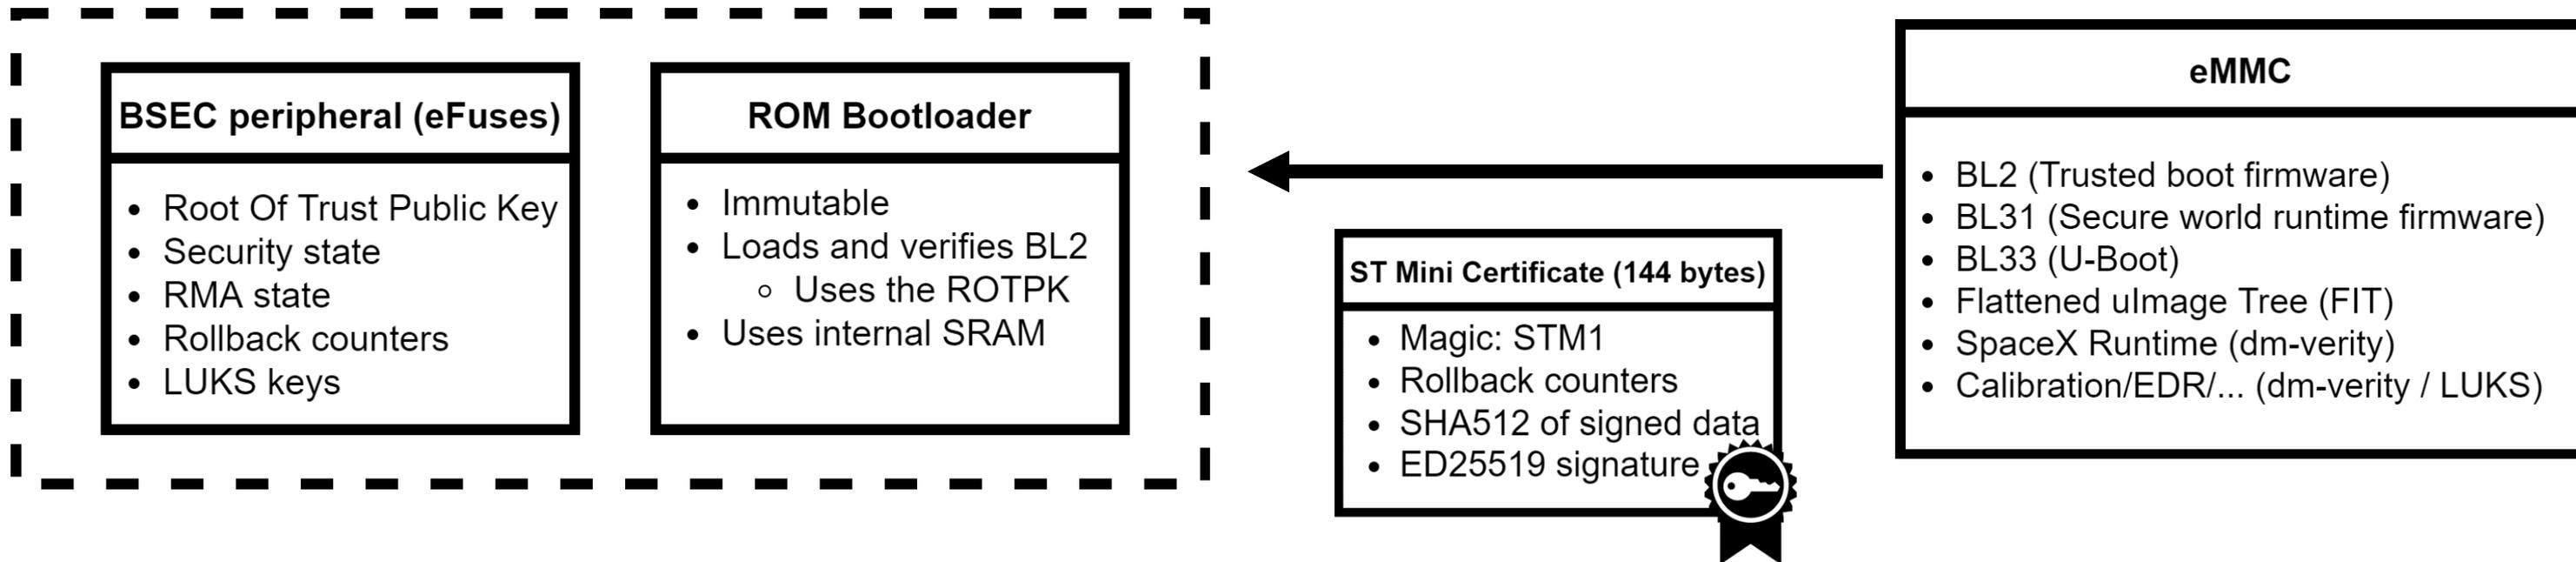
SoC Root of Trust

1. BL1 loads BL2 certificate from eMMC
2. BL1 verifies the certificate's signature

3. BL1 loads the BL2 firmware from eMMC
4. BL1 verifies that SHA512(BL2) matches the hash contained in the certificate

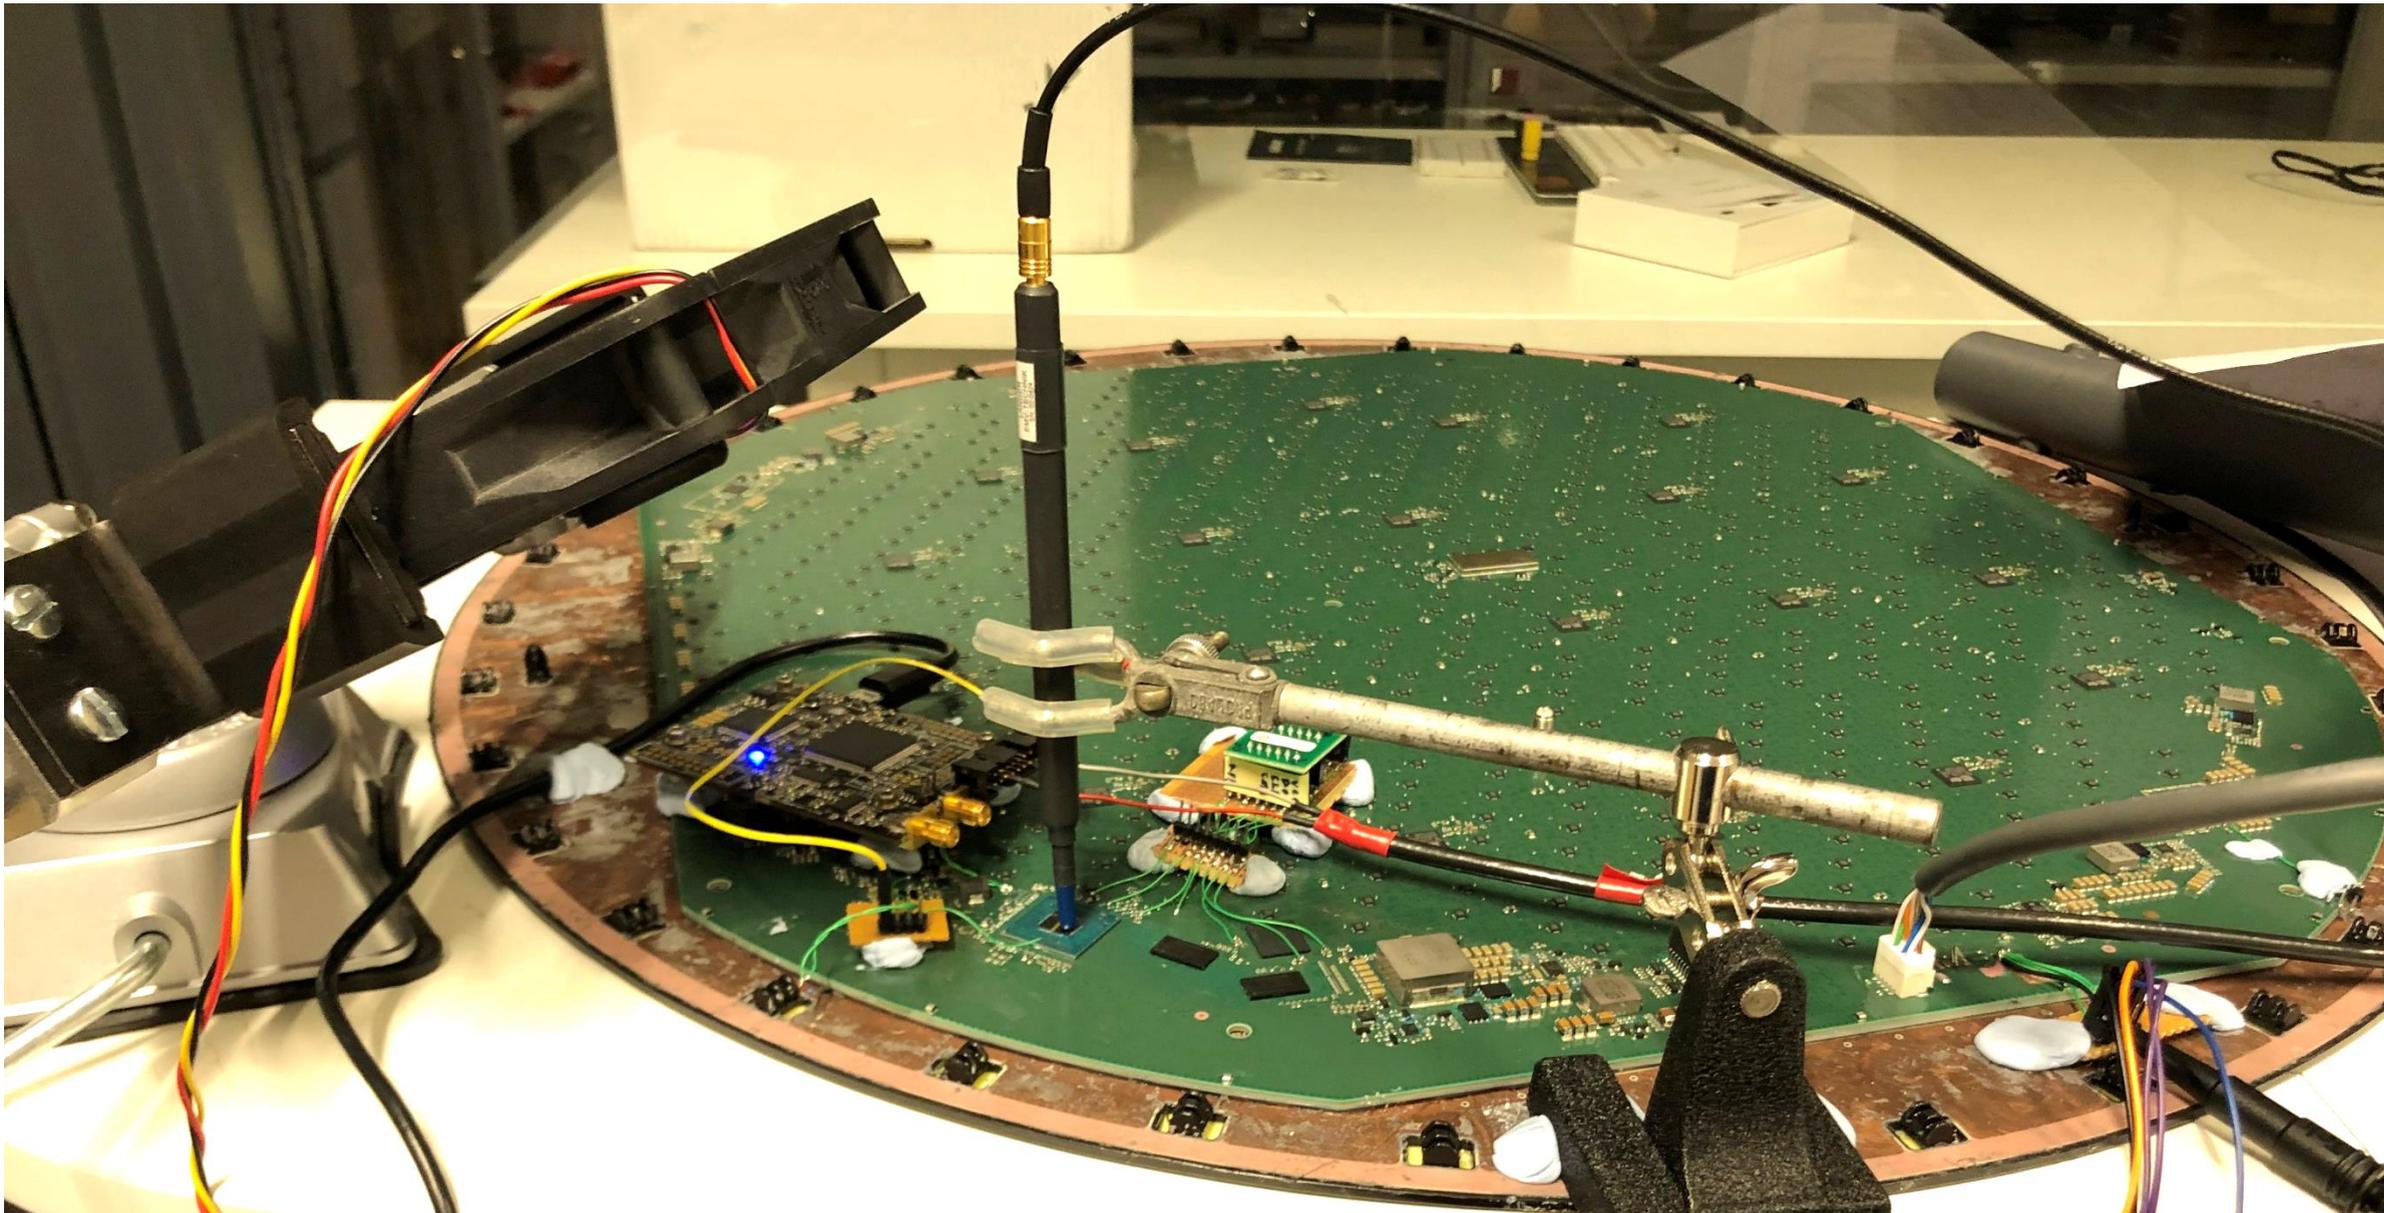
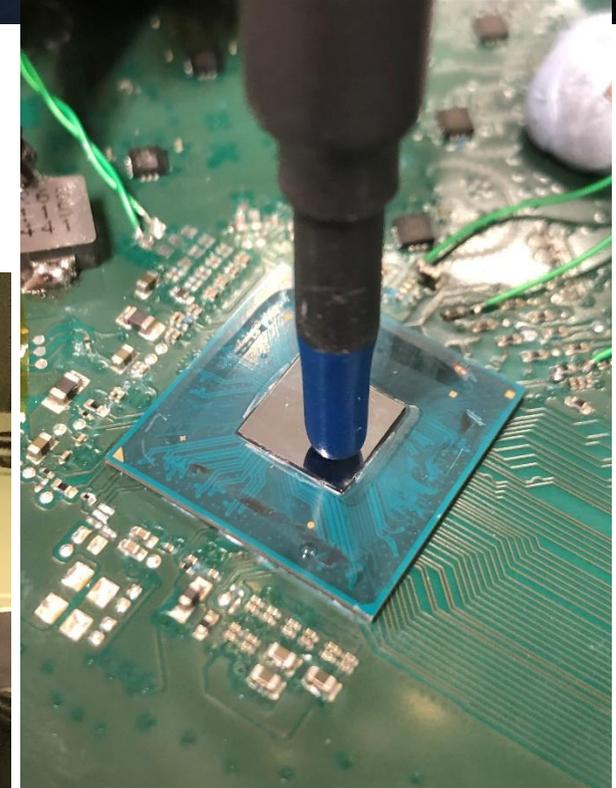
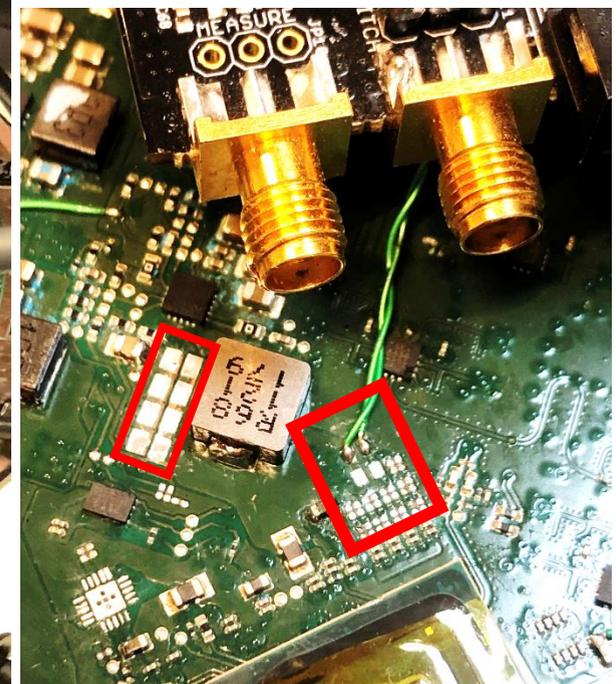
BL1 Glitch setup

- Try to boot with (in)valid signature, hash and firmware
- Try to glitch a valid certificate into a signature verification failure
