KU LEUVEN

Glitched on Earth by Humans: A Black-Box Security Evaluation of the SpaceX Starlink User Terminal

Lennert Wouters

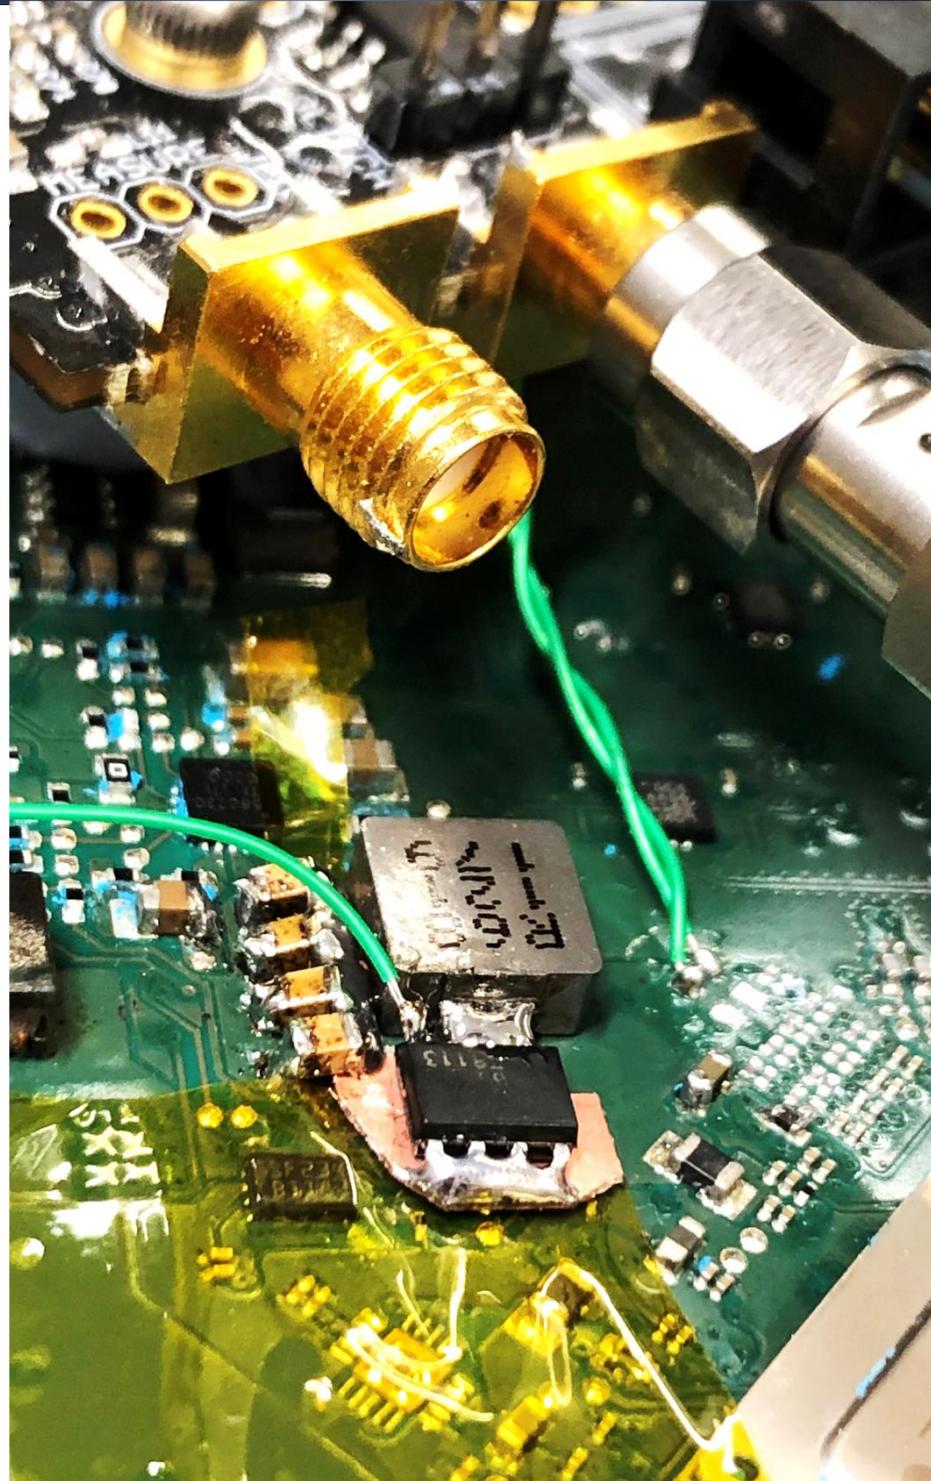
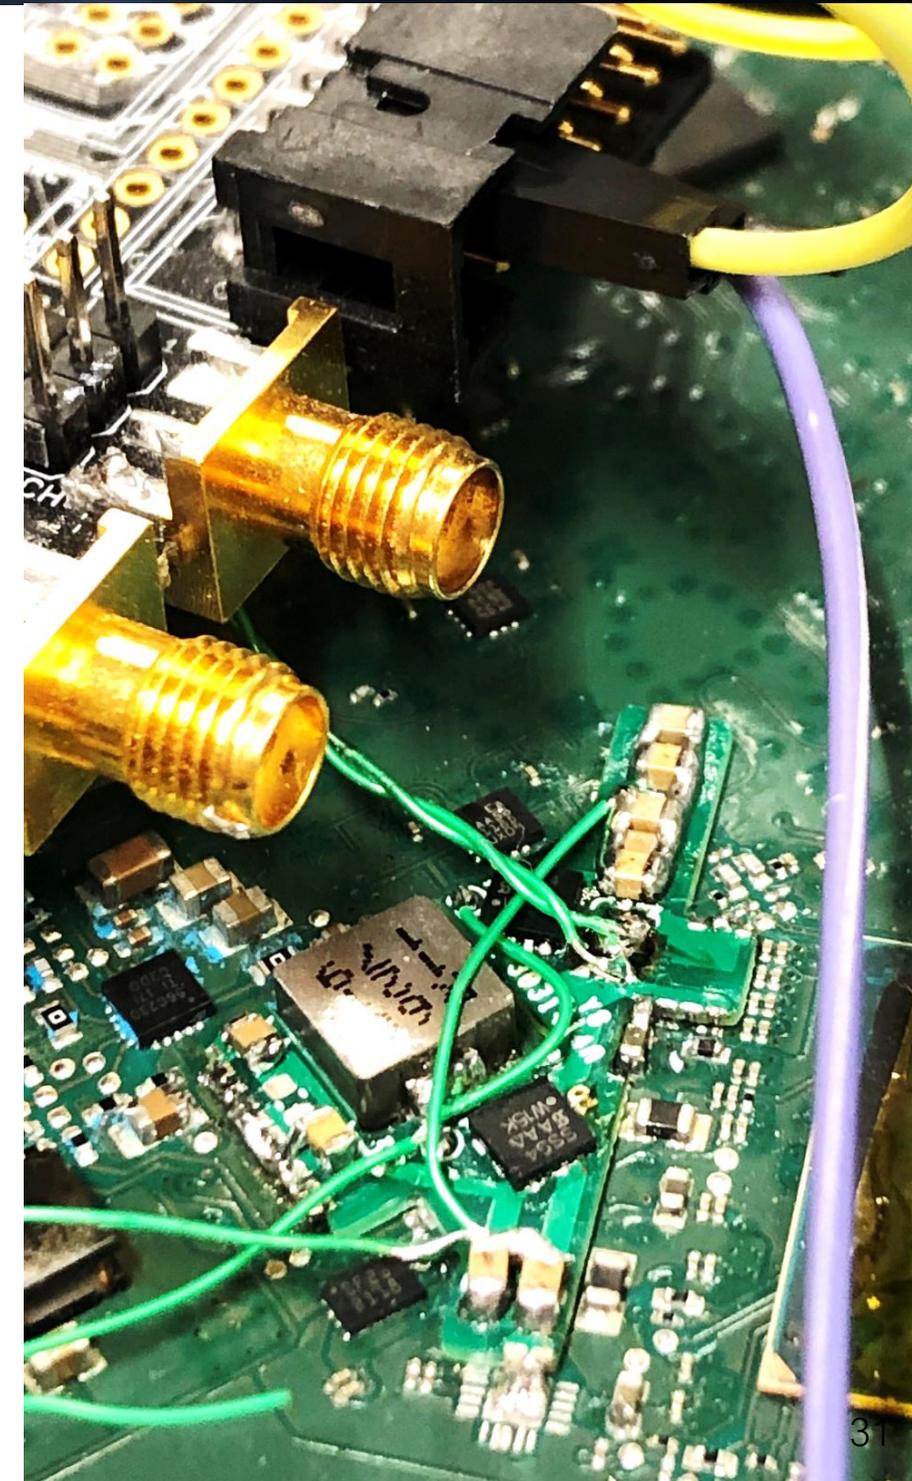
Enabling decoupling capacitors

- Decoupling capacitors are needed for later boot stages
- Experimented with:
 - N-channel MOSFETS
 - P-channel MOSFETS
 - High/Low side switching
 - Gate voltage
 - MOSFET drivers
 - Capacitor sizes
 - Timing

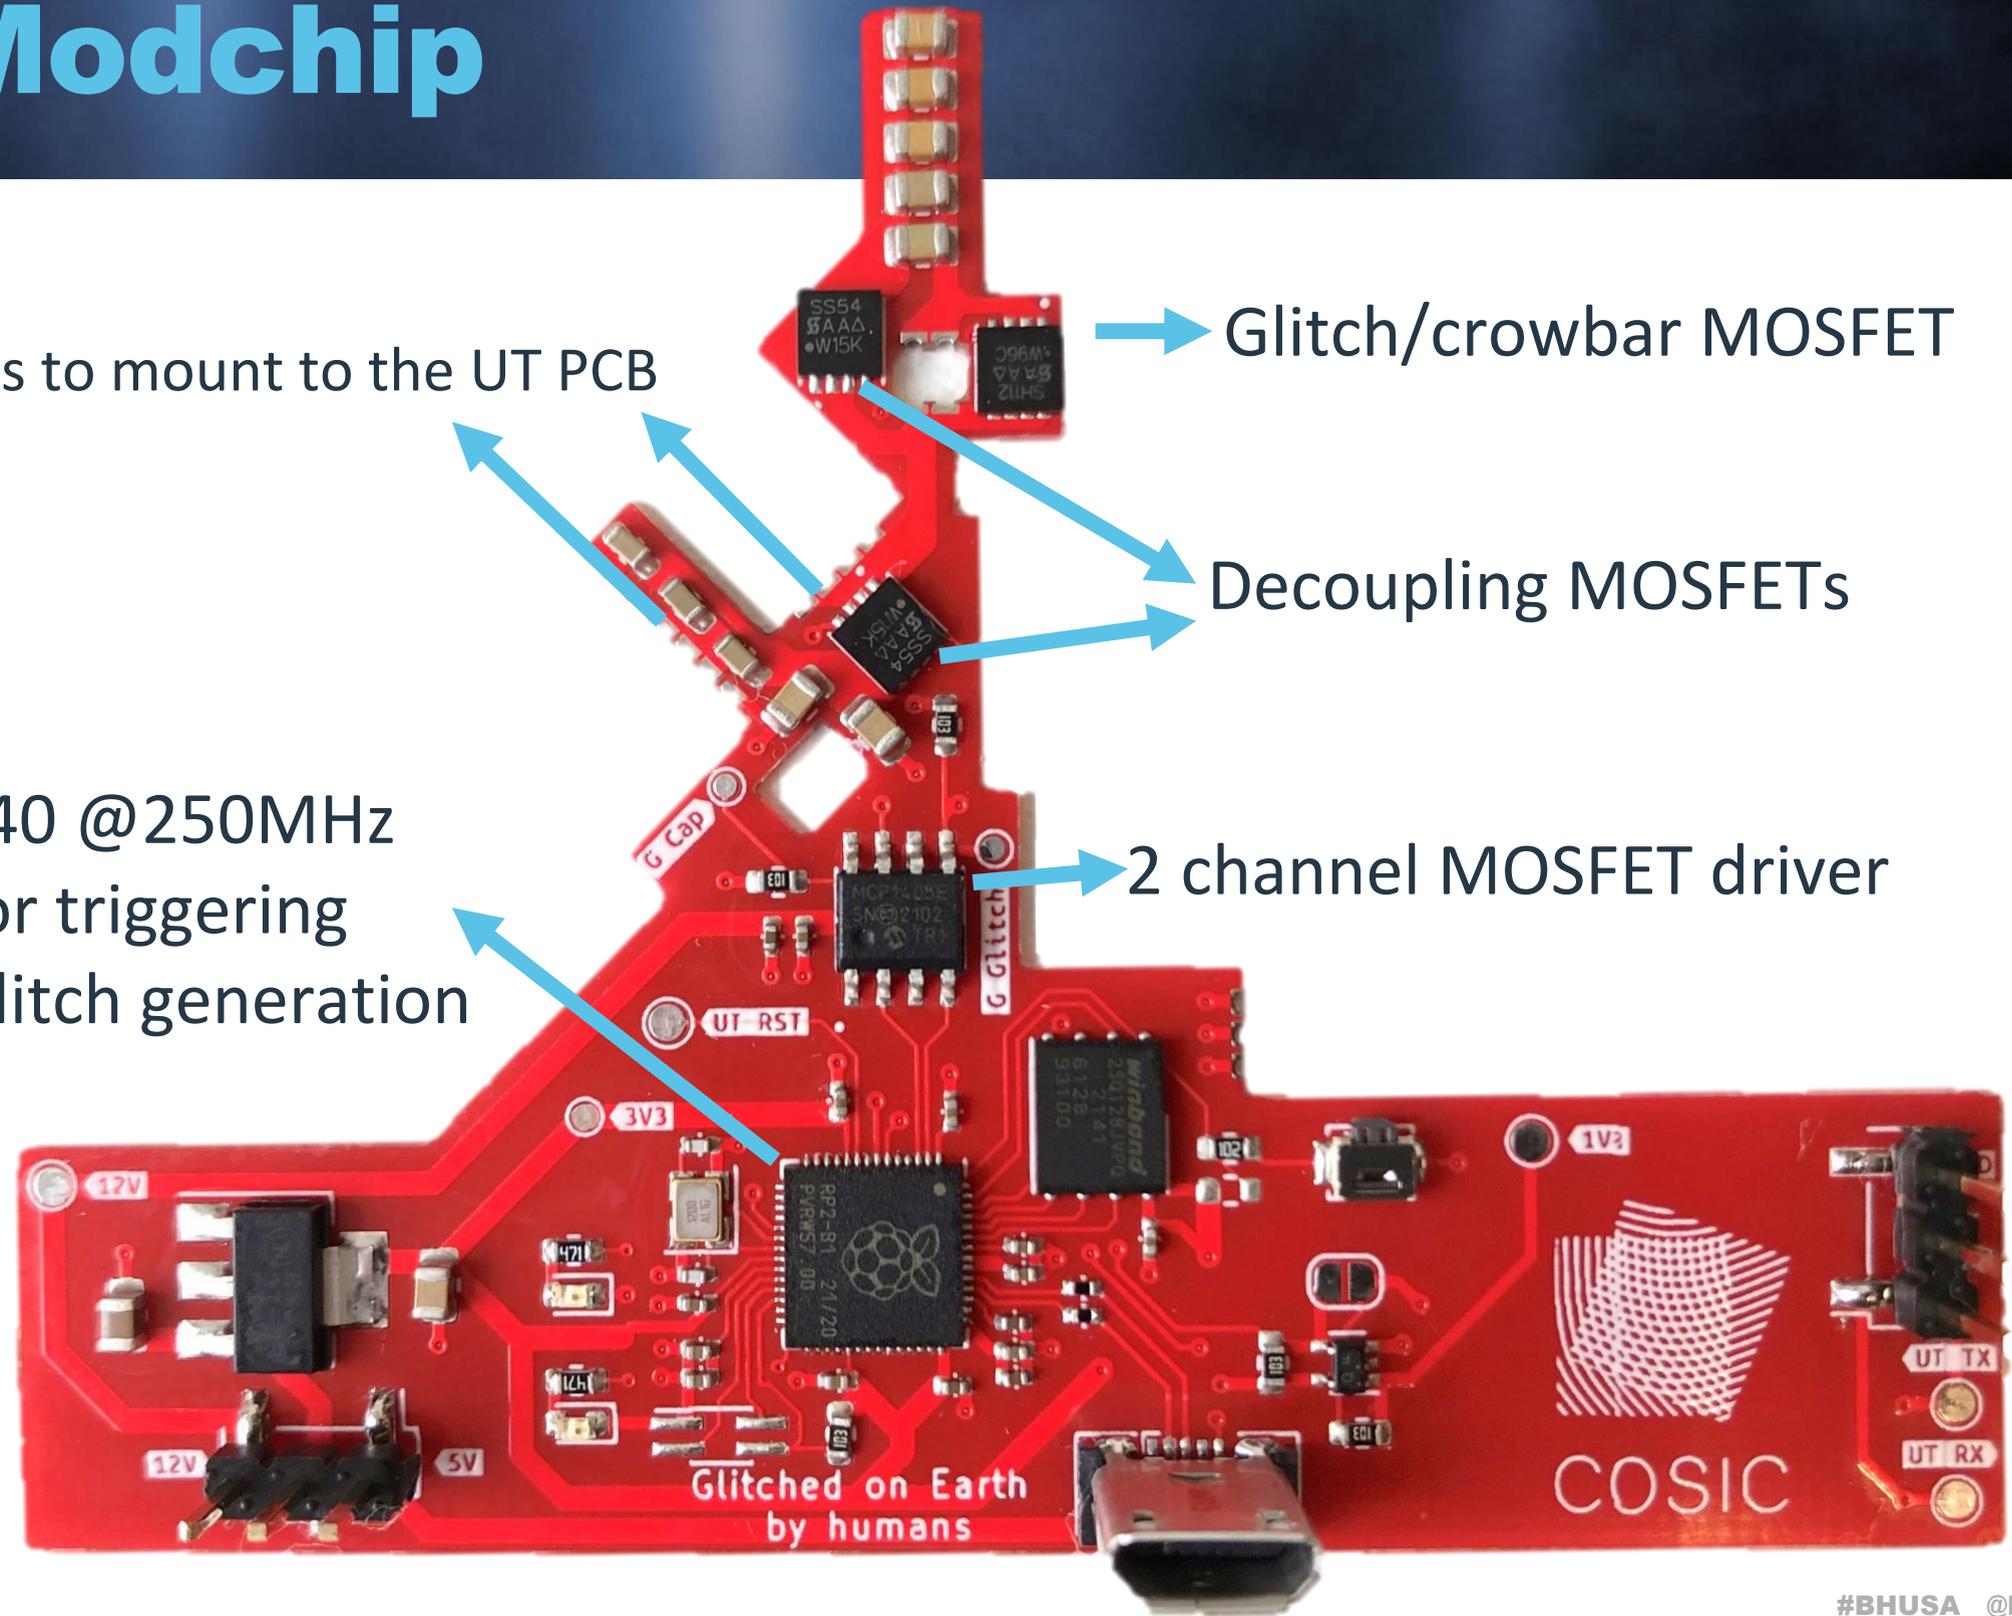
Glitch/crowbar MOSFET

Decoupling MOSFETs

2 channel MOSFET driver

6 cm
2,36"

0,8 mm

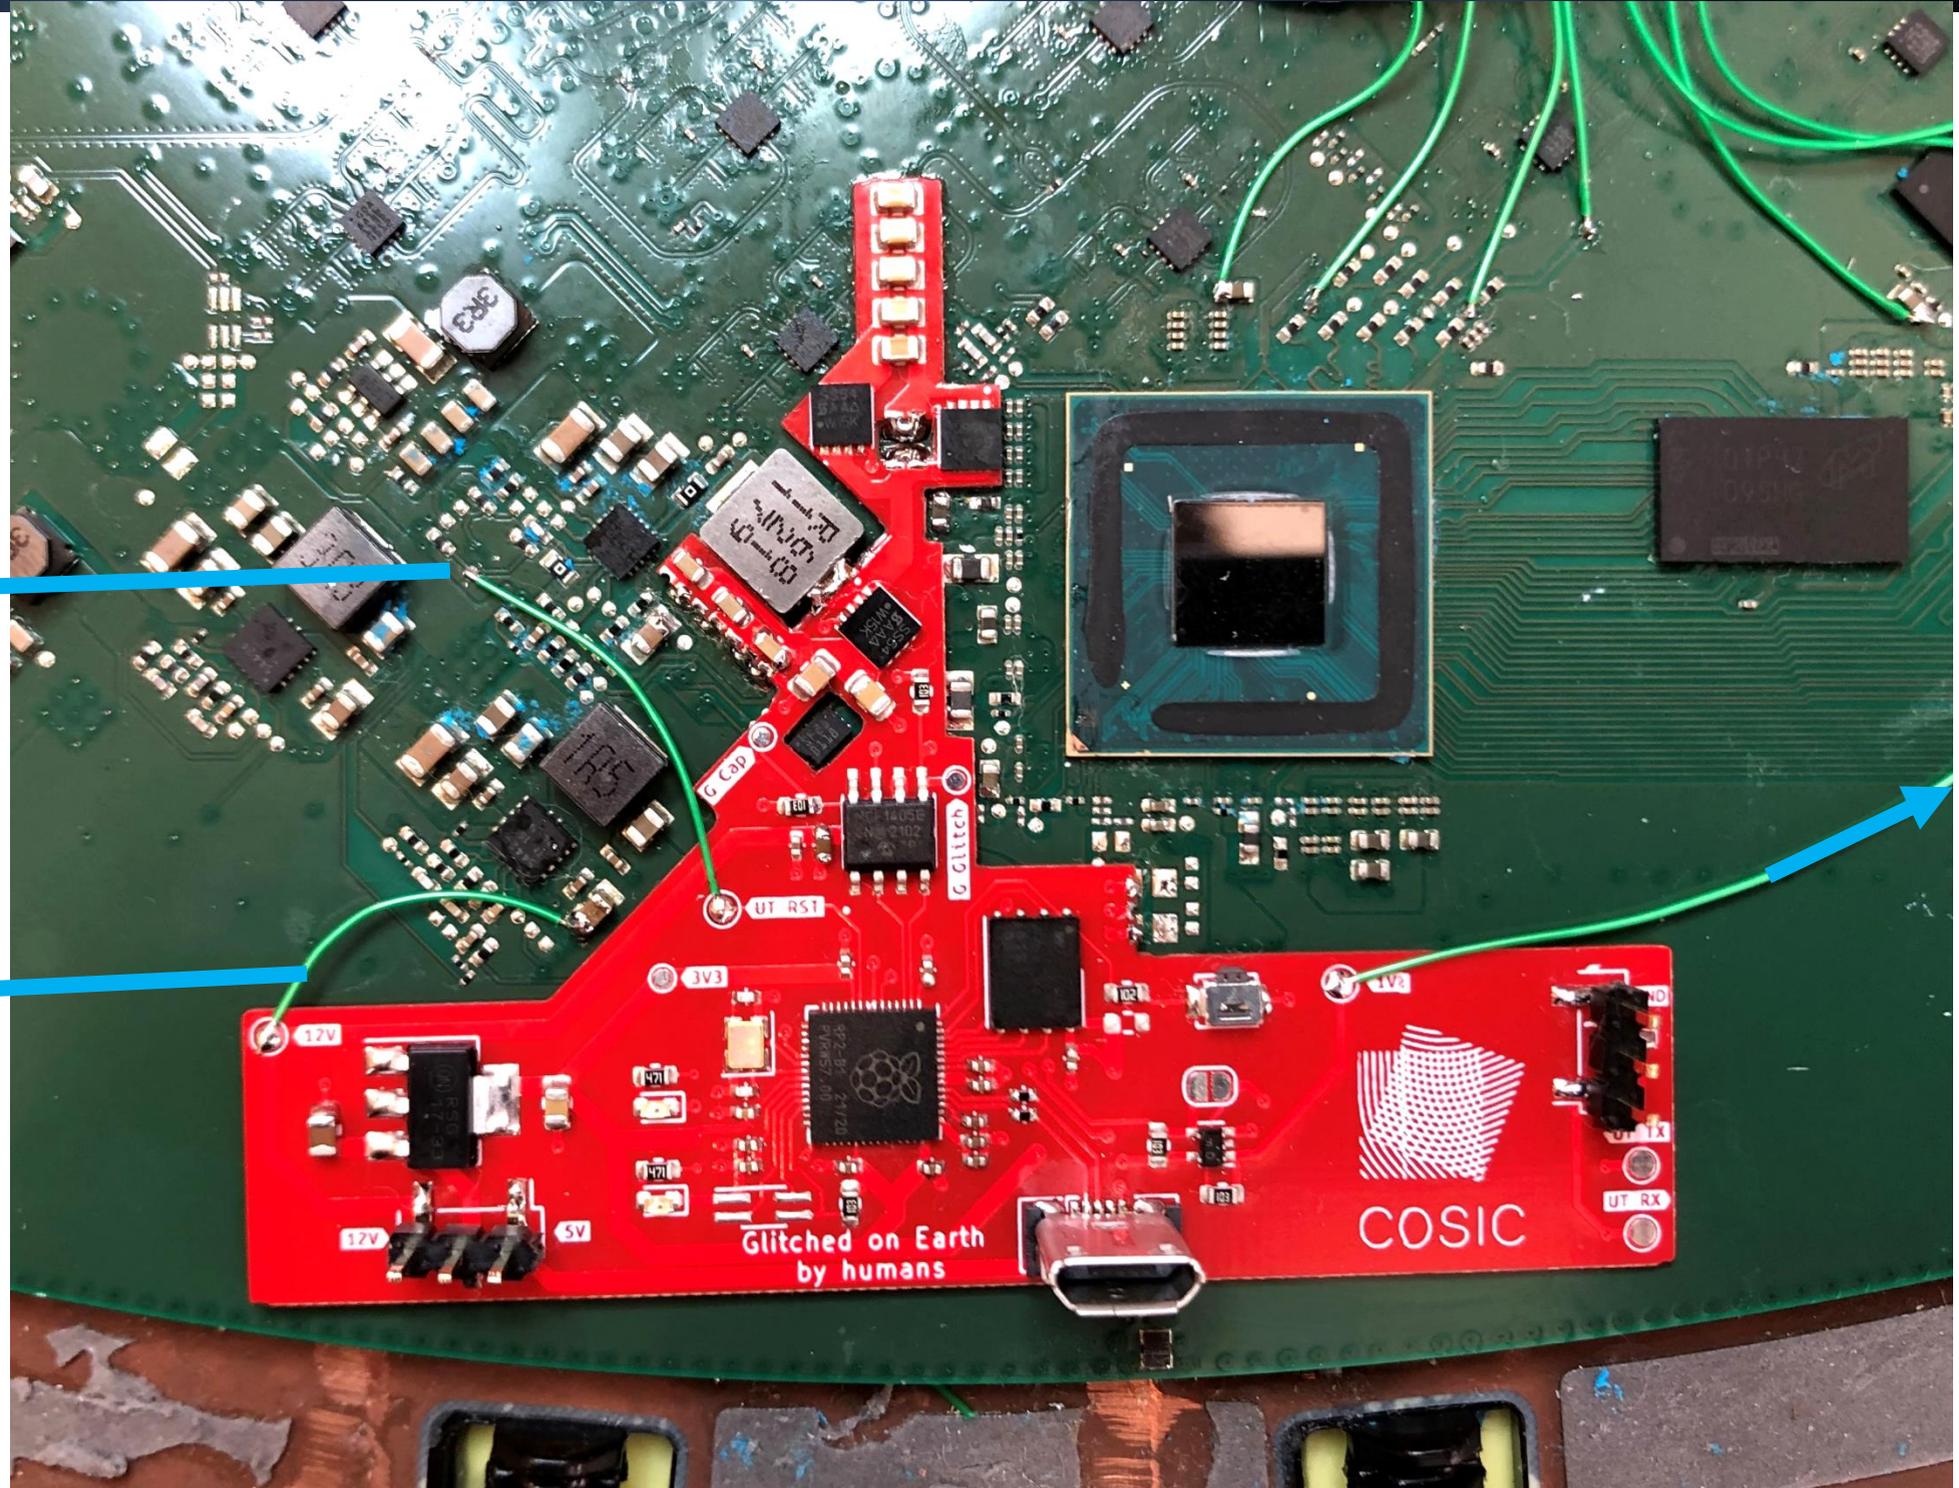
Installed modchip

Core voltage regulator
enable pin
(for power cycling)

12V for MOSFET drivers
and standalone power

1V8 for
level shifter

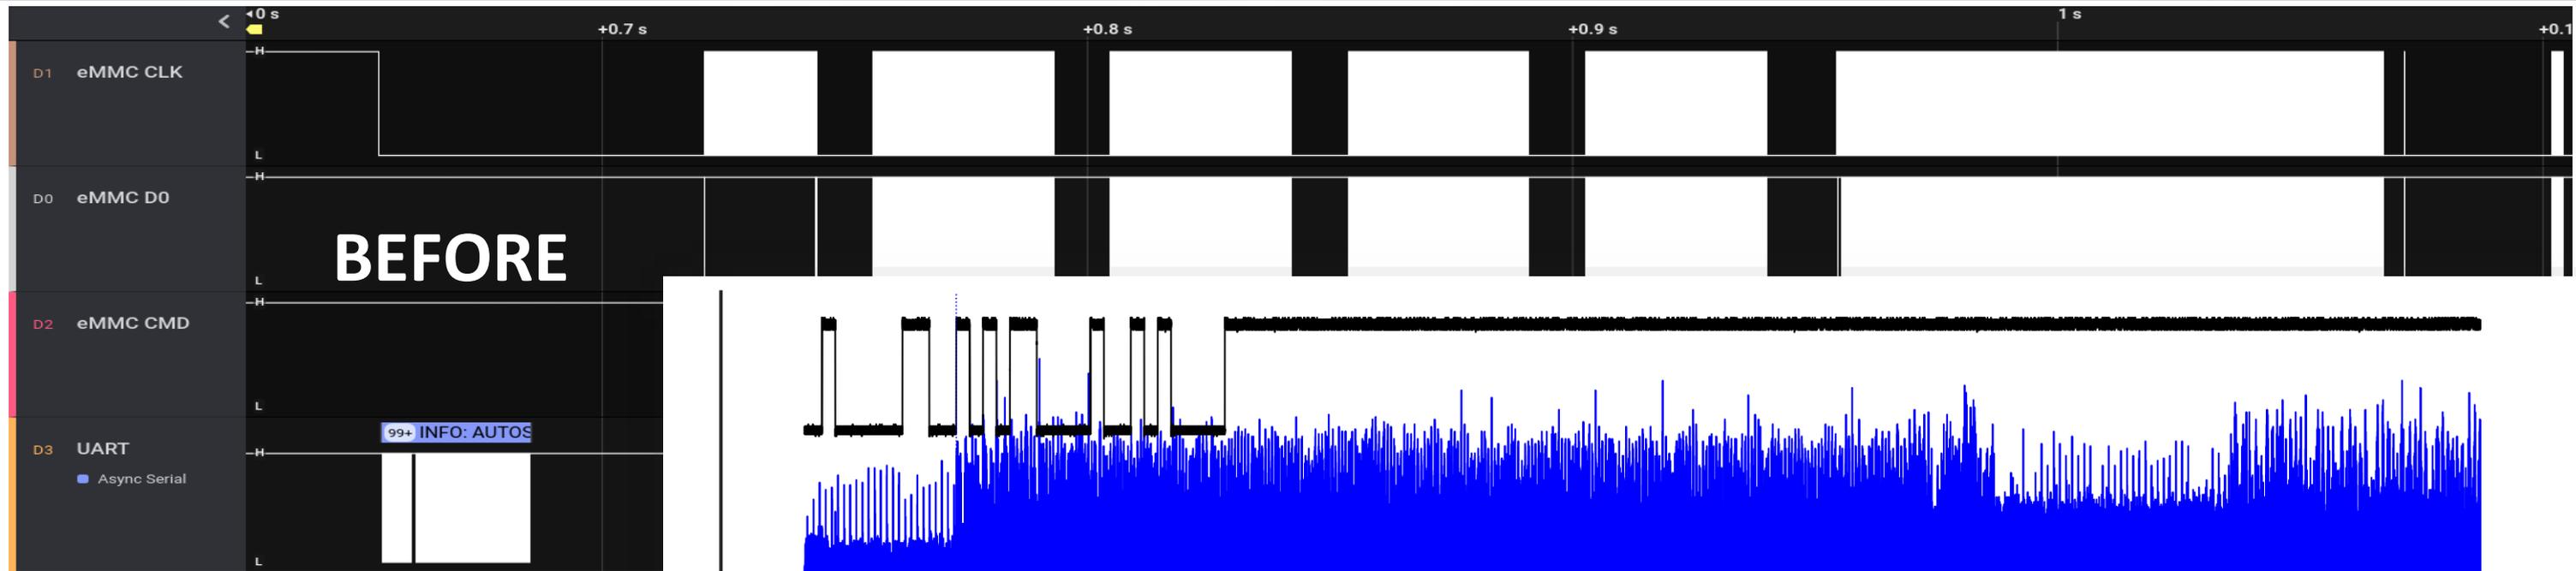
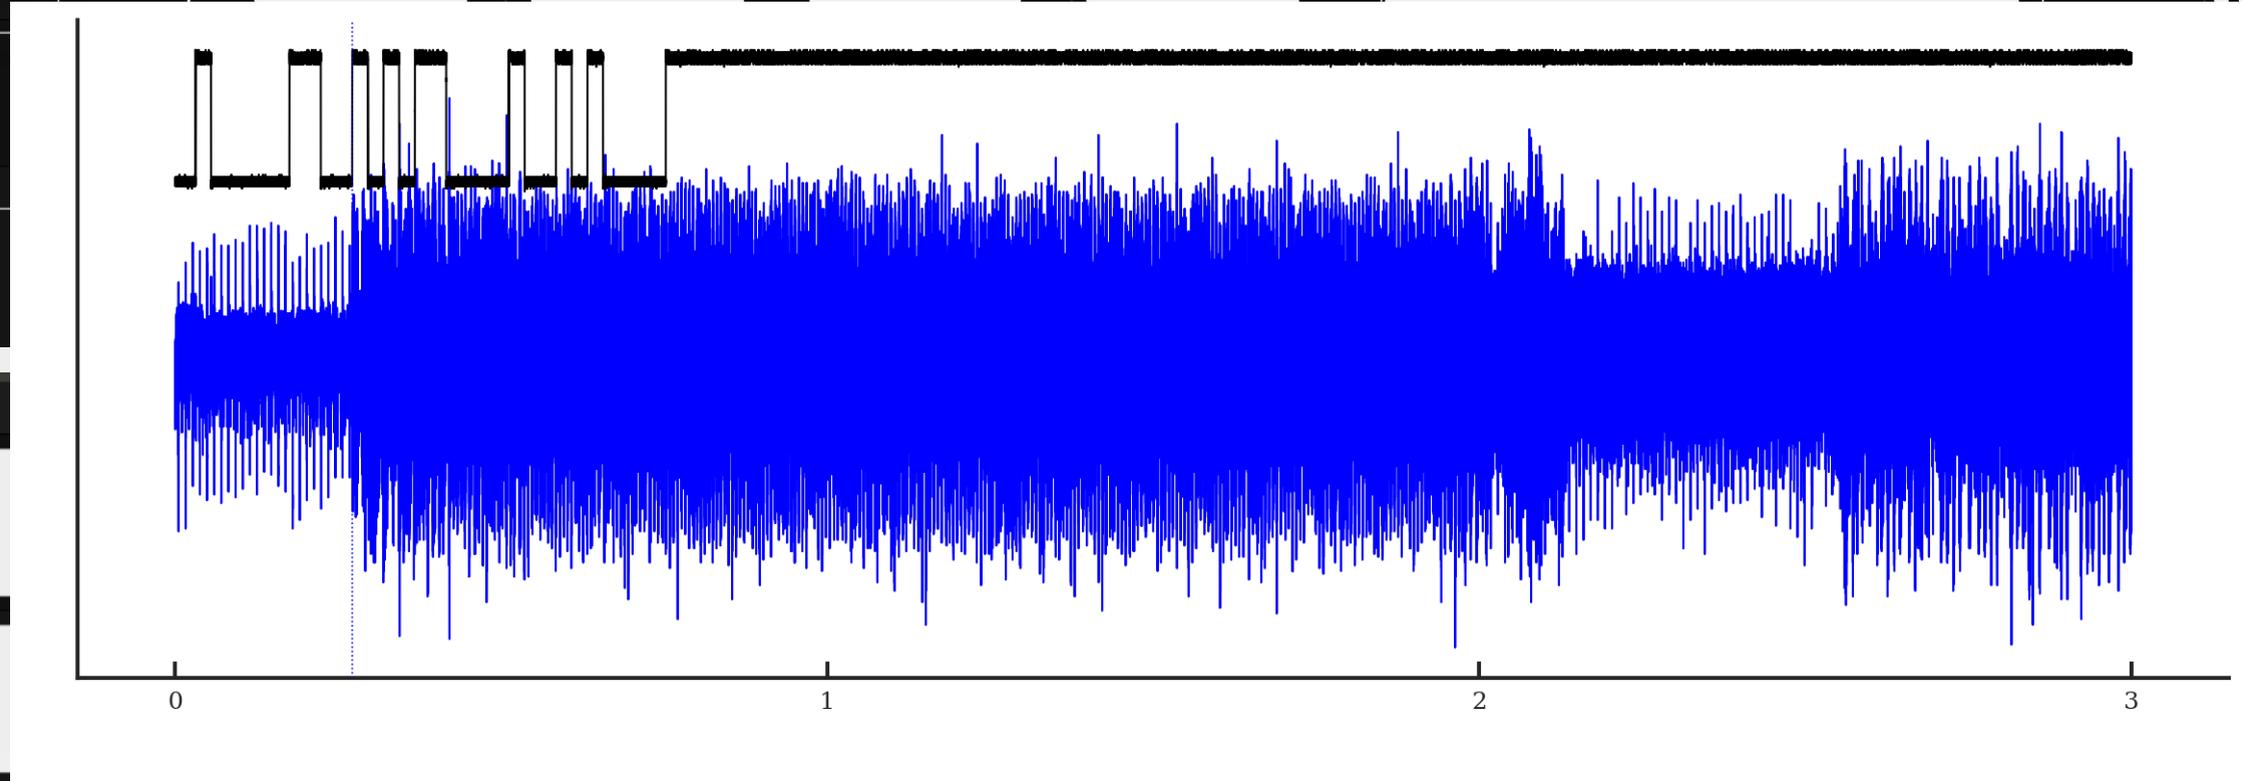
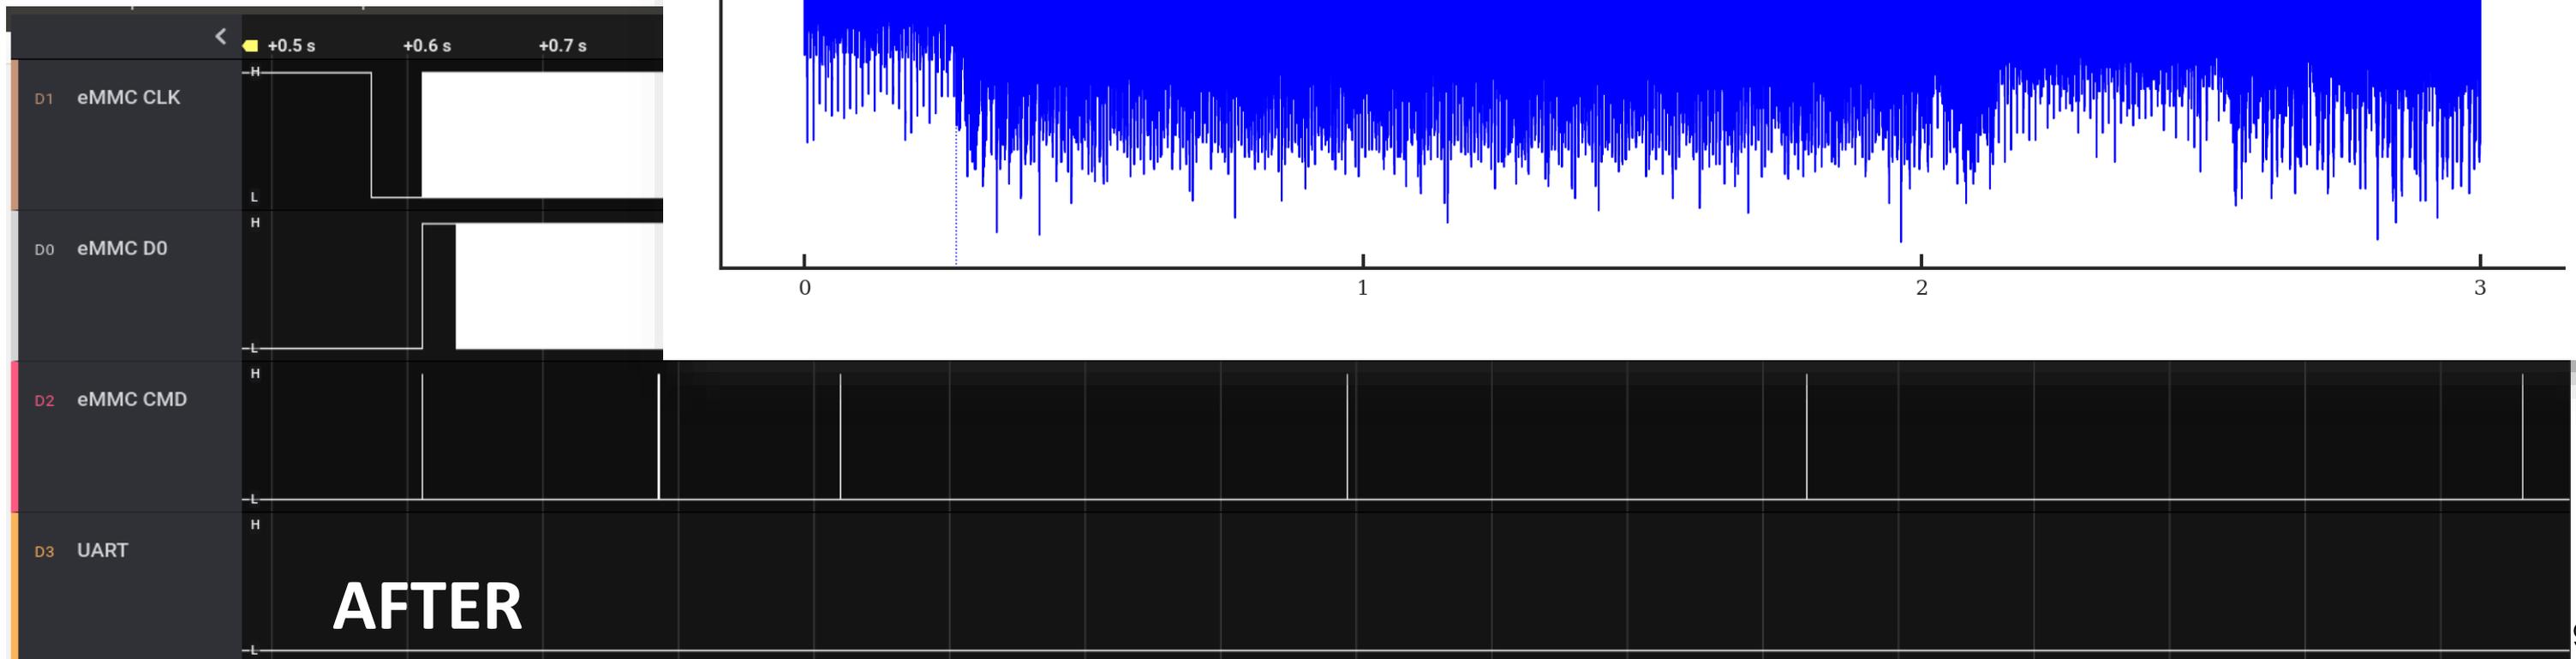
Adapt

- Trigger on eMMC D0 instead of UART
- Modchip could be easily adapted
 - Disconnect UT UART TX
 - Connect to eMMC D0
 - Update glitch parameters from Python
- Alternative: new PCB revision
